**Asbestos Survey For**

**Advanced Demolition**

**Spotlight**

**In accordance with HSG264**

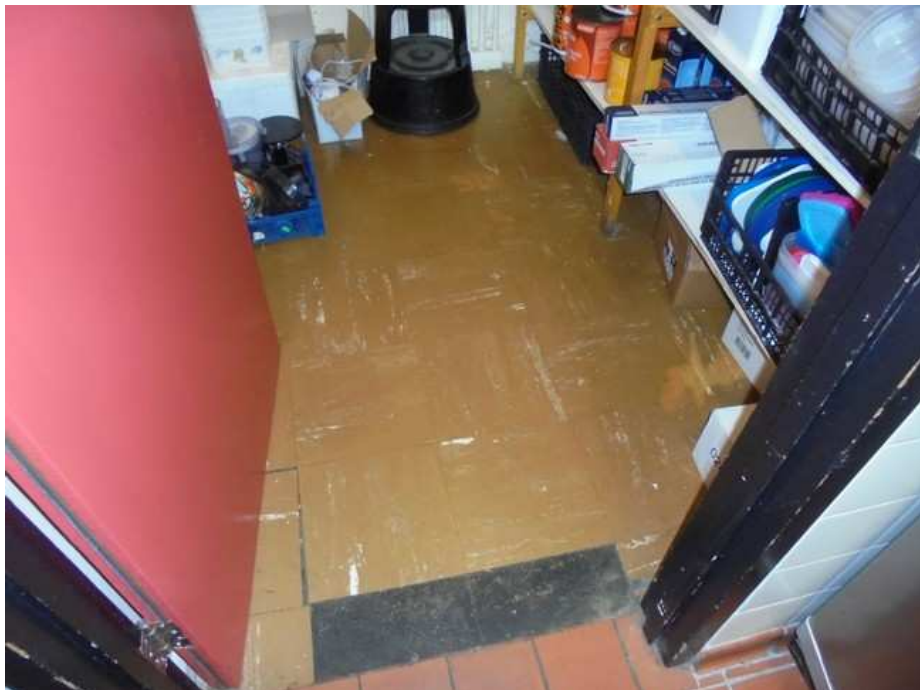
Material Comments: Damaged/Loose tiles in areas.

Action: Removal
