## LEGAL SUMMARY OF CASE (THIRD PARTY REPRESENTATION)

Appeal Reference: APP/W1905/C/26/3378144

Site: Former Gravel Pit (Darcy's Place / Little Broomfield), Church Lane, Wormley

## STATEMENT OF EVIDENCE

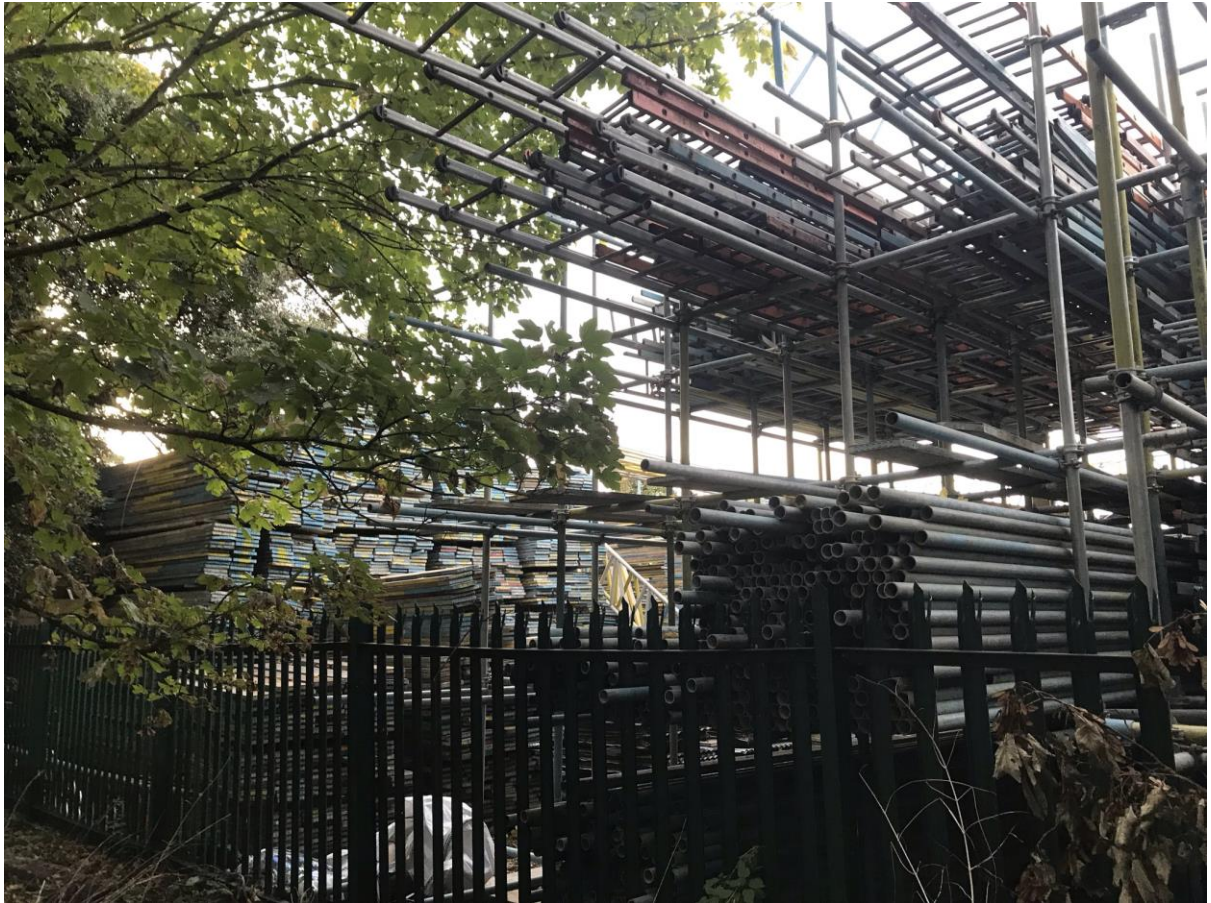
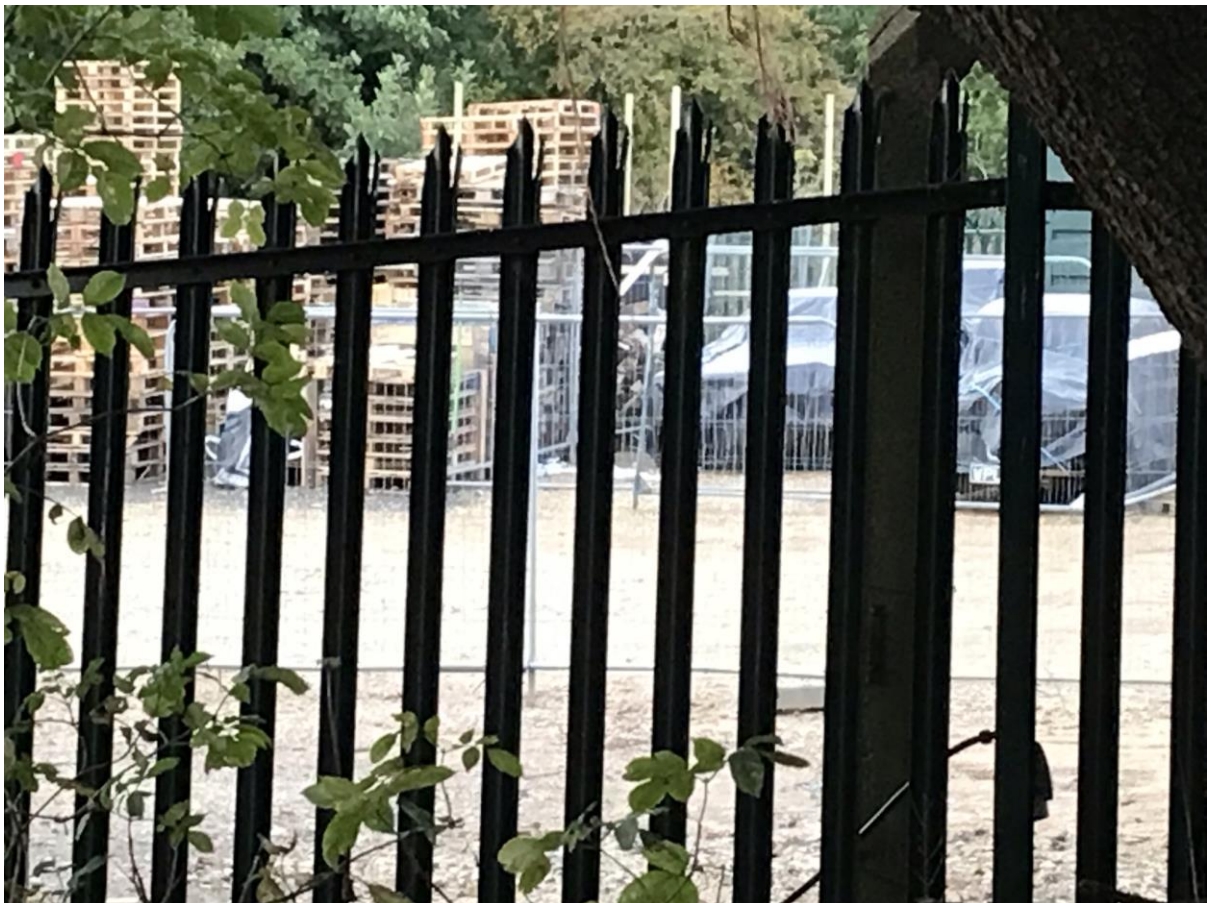
Figure 2 – Yard Storage / Pallets / Vehicles

Purpose: Shows unauthorised commercialisation and hard surfacing:

Key Point:

Organised storage confirms industrial use

Not incidental or agricultural

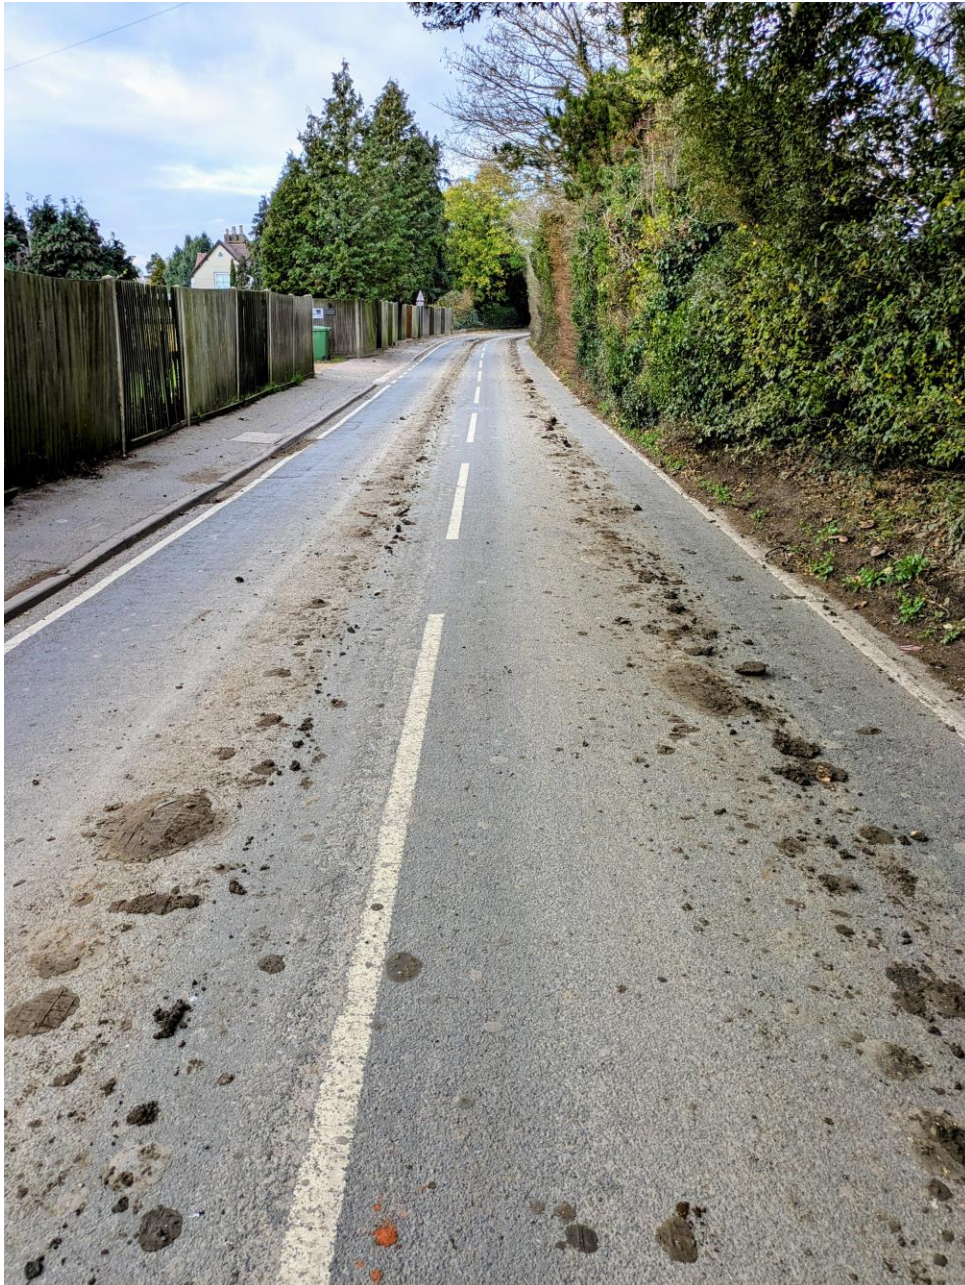
Figure 3 – Mud Deposited on Church Lane

Significant mud deposition

Slippery road conditions

Risk to public safety

Purpose: Demonstrates direct public safety risk

Key Point:

Material tracked from site

Extent exceeds normal rural conditions

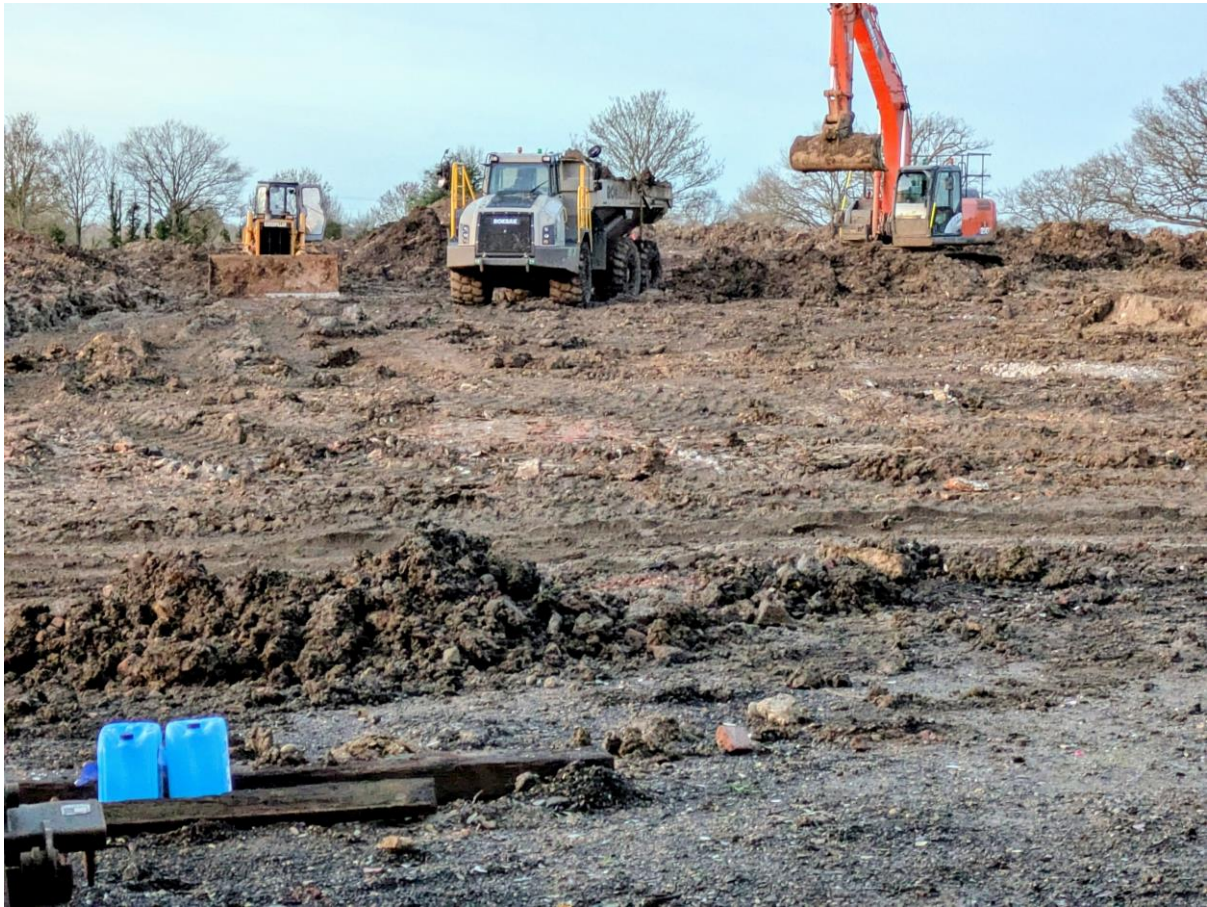
Figure 4 – Heavy Machinery & Land Raising

Purpose: Demonstrates scale of operation

Key Point:

Excavator + articulated dump truck

Clear engineered land raising

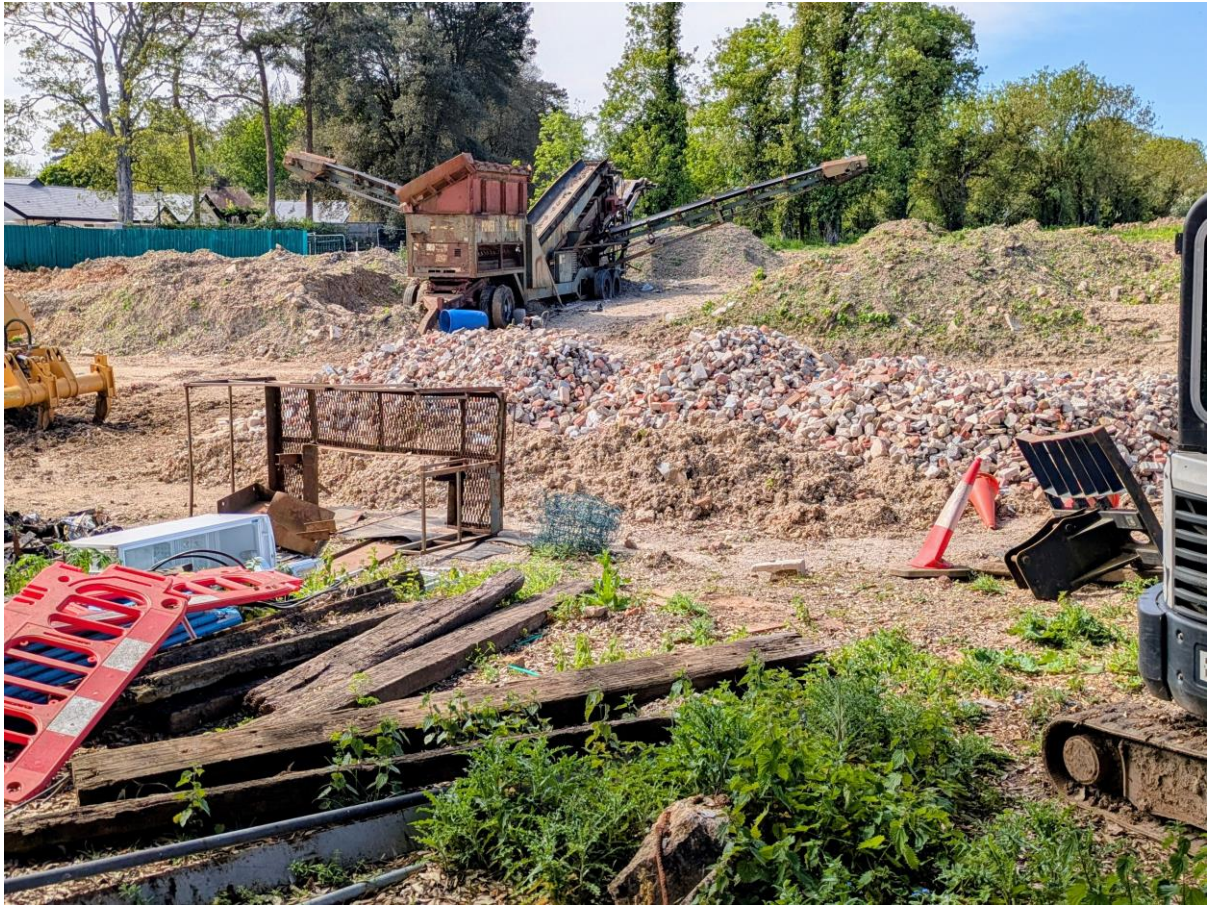
Figure 5 – Mixed Hardcore and Brick

Purpose: Challenges “inert soil” claim  
Key Point:

Visible construction waste  
Mixed material types  
Suggests sorting / processing  
8. Waste Processing Activity

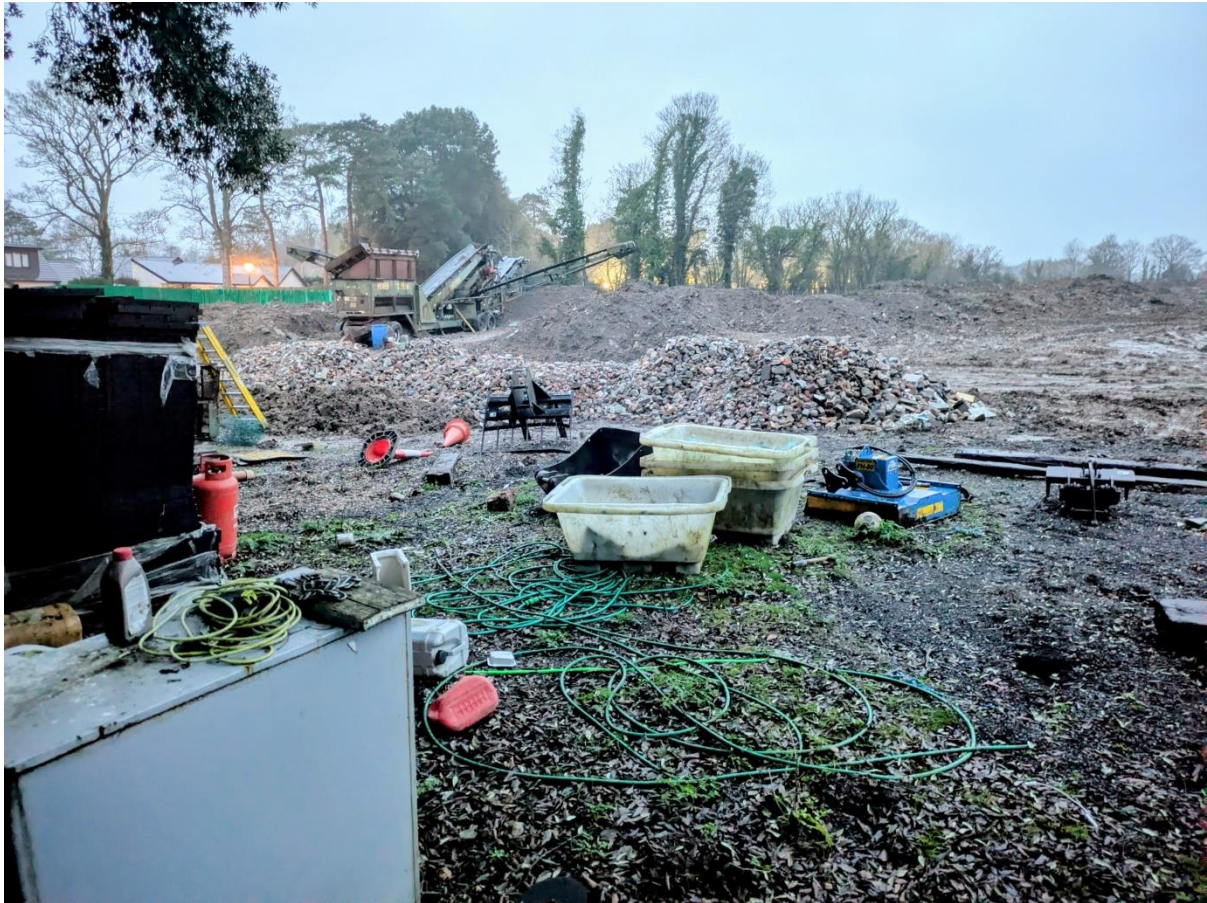
Figure 6 – Screening Plant & Stockpiles

Purpose: Demonstrates waste treatment

Key Point:

Material sorting underway

Not simple deposition

Likely regulated activity

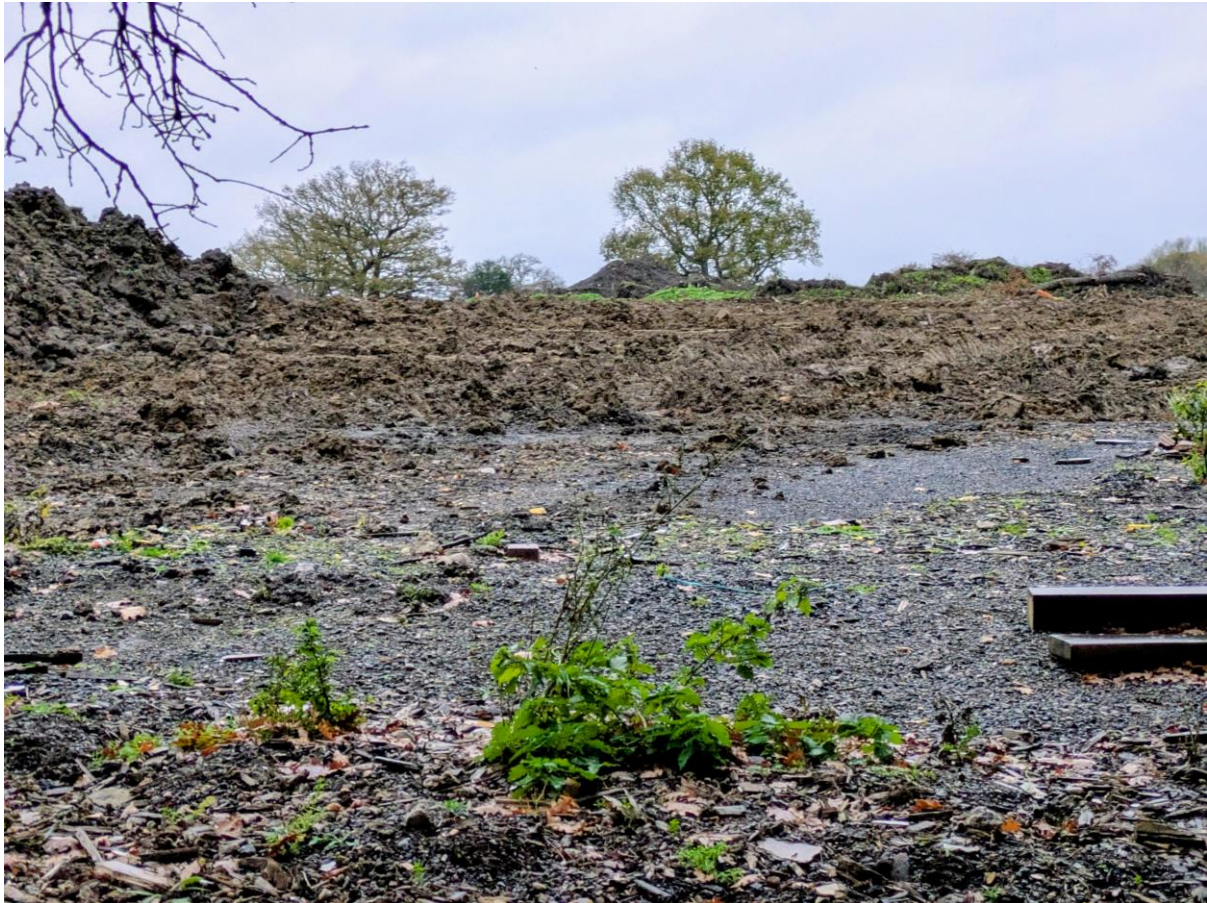
Figure 7 – Hardstanding Beneath Raised Levels

Purpose: Demonstrates non-compliance

Key Point:

Surface layer clearly visible

Overlaid by imported soil

Indicates burial, not removal

Immediate cessation of activity  
Full investigation of materials  
Removal (not burial) of hardstanding  
Environmental remediation  
Restoration to wild meadow condition  
16. Conclusion

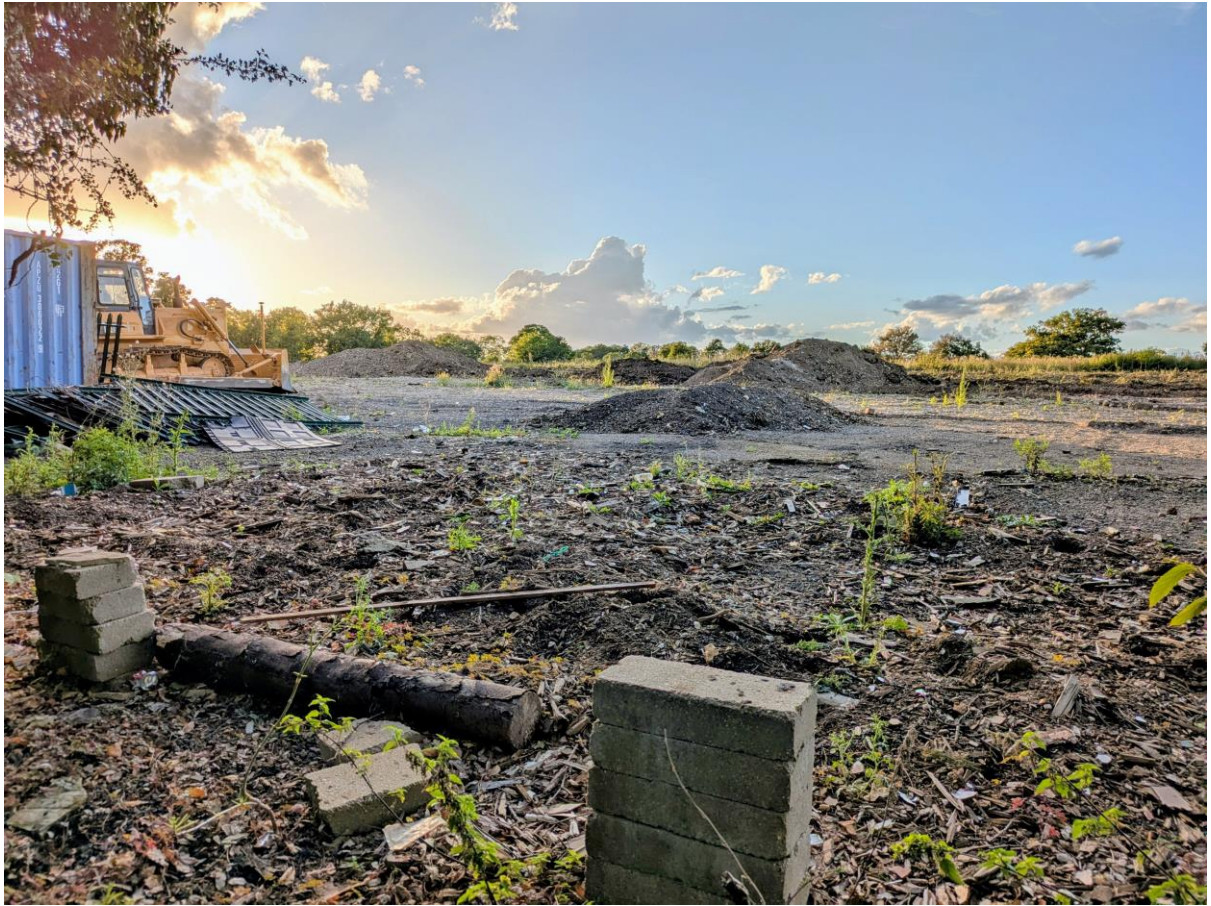
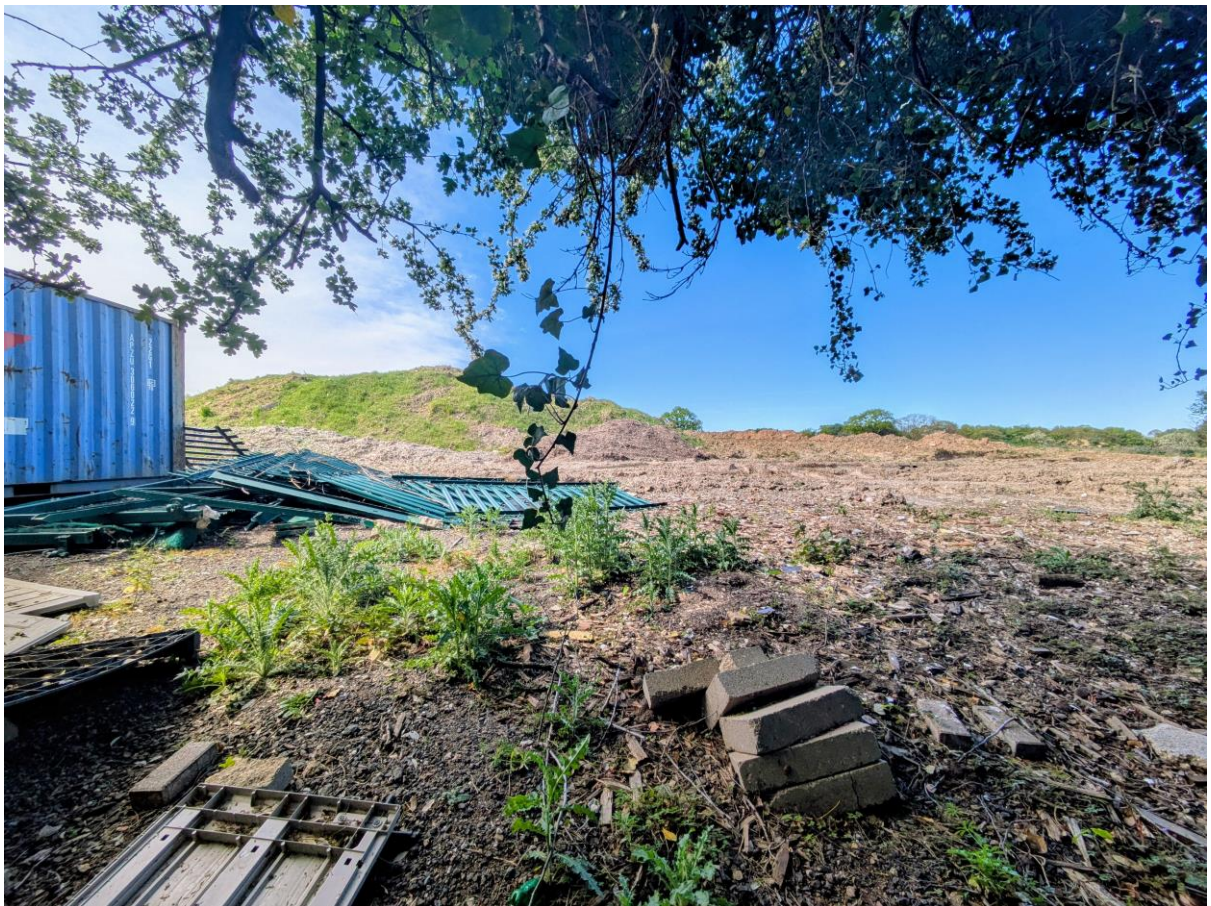
Figure 8 – Raised Landform / Material Mounds

Significant elevation increase 2-4m over much of the site

Purpose: Shows final outcome of works top photo Sep2025 lower Apr 2026

Key Point:

Artificial landform created

Scale inconsistent with “minor engineering”
