**Asbestos Survey For**

**Advanced Demolition**

**Spotlight**

**In accordance with HSG264**

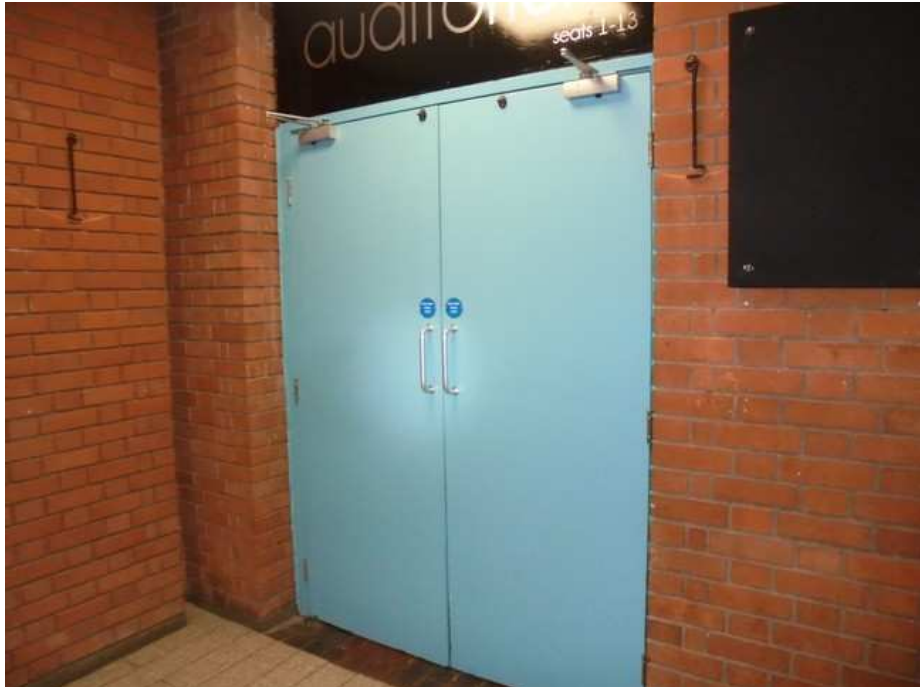
No access was gained to inspect within fire doors.

Apply Warning Labels

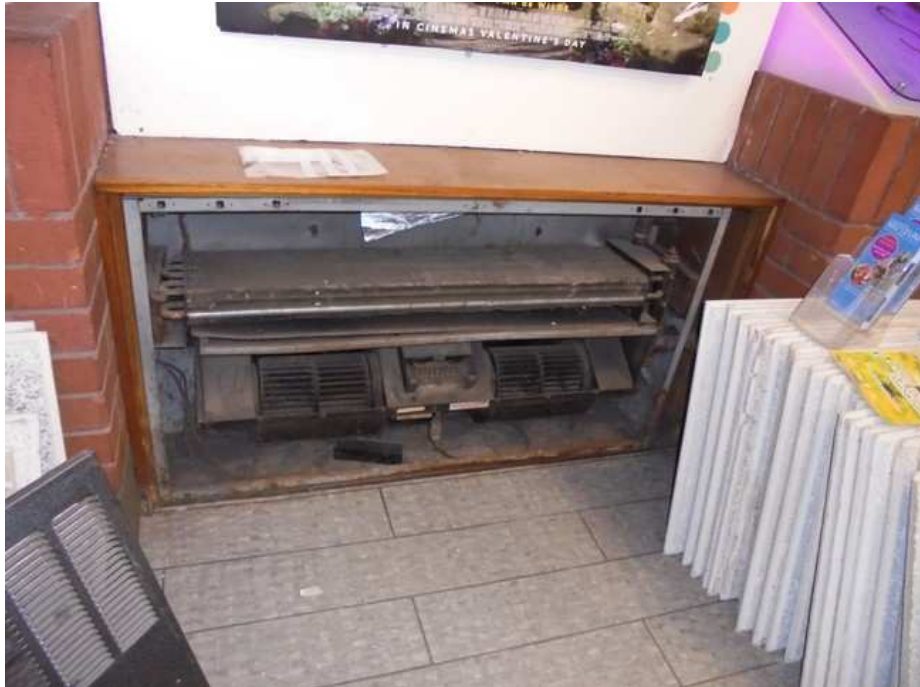
Due to the nature of the survey, no access was gained to inspect below floor coverings.

Apply Warning Labels

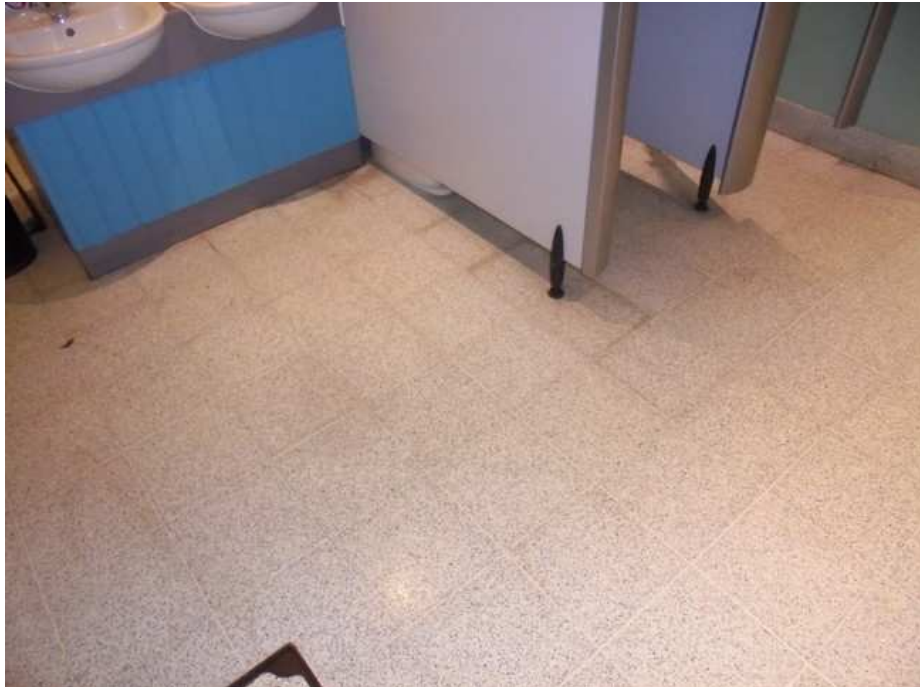
Due to the nature of the survey, no access was gained to inspect below floor coverings.

Apply Warning Labels

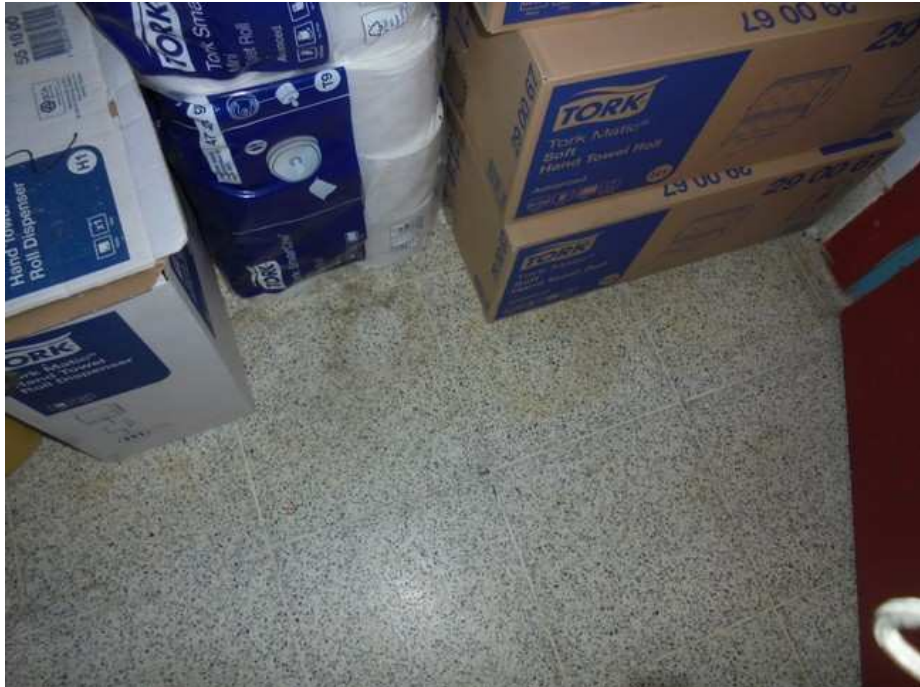
Due to the nature of the survey, no access was gained to inspect below floor coverings.

Apply Warning Labels

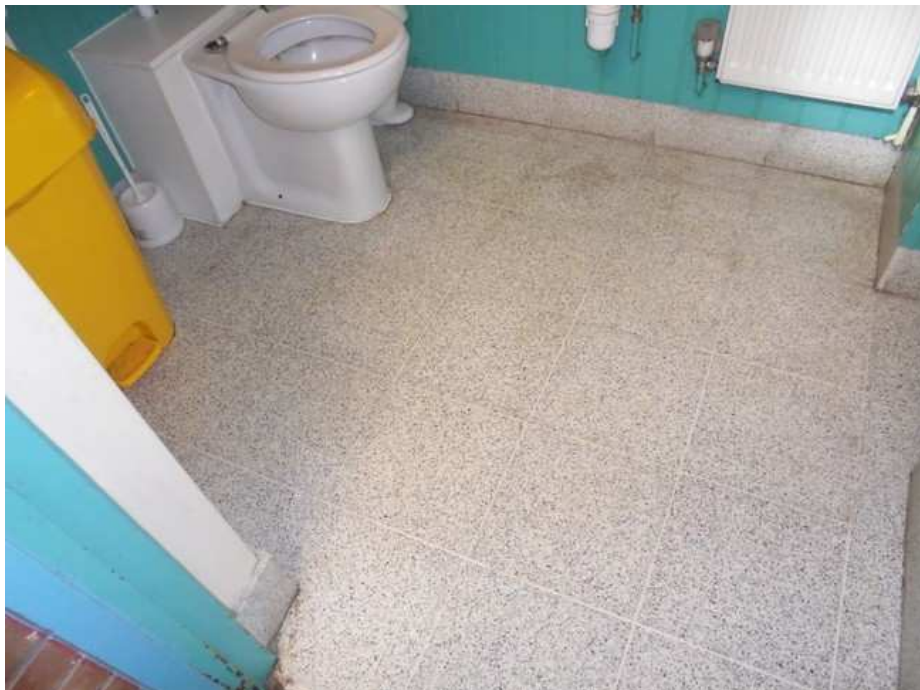
Due to the nature of the survey, no access was gained to inspect below floor coverings.

Apply Warning Labels

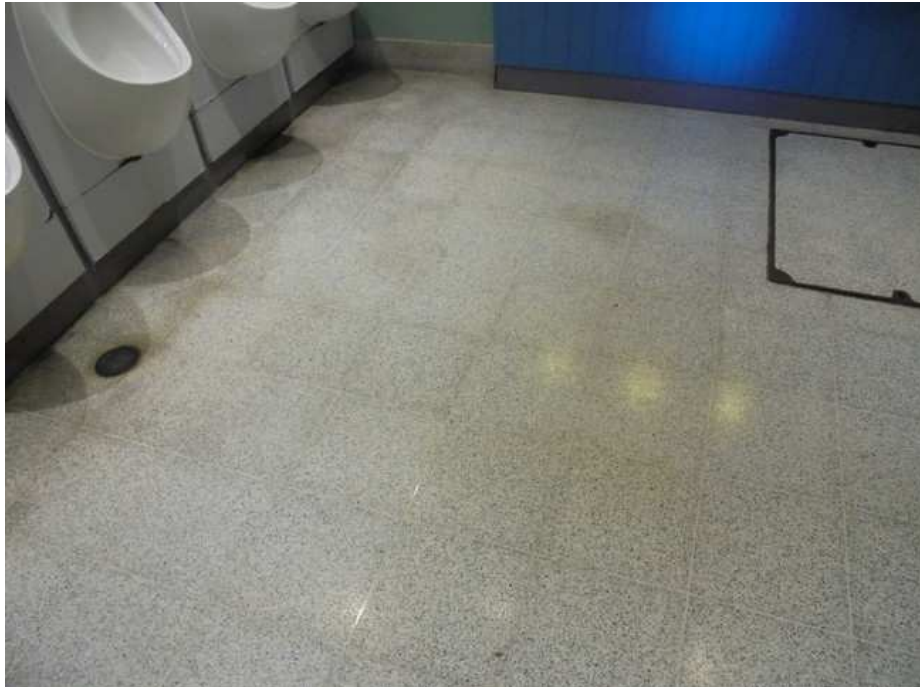
Due to the nature of the survey, no access was gained to inspect below floor coverings.

Apply Warning Labels

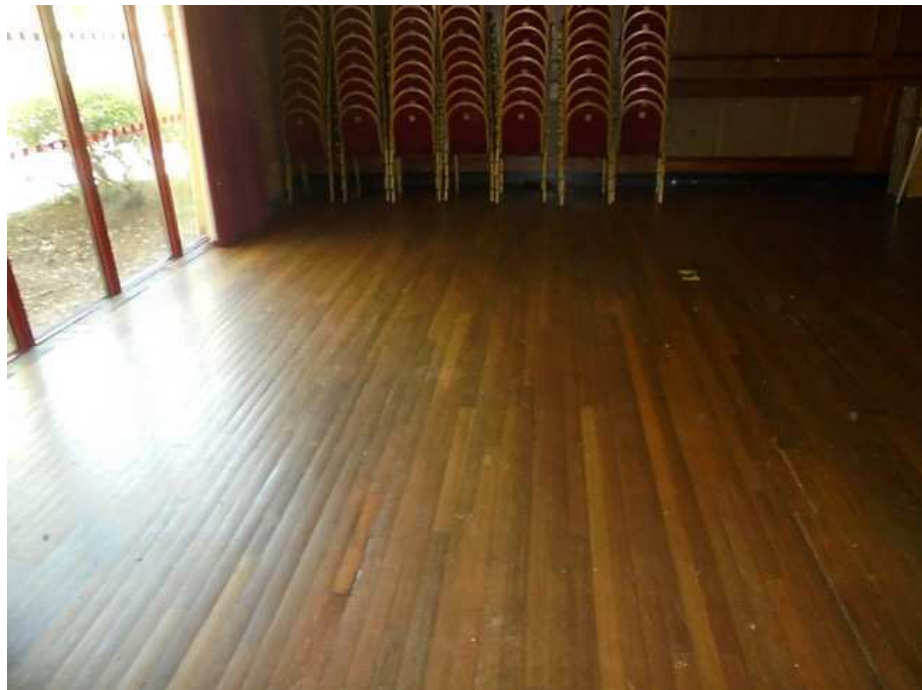
Due to the nature of the survey, no access was gained to inspect below floor coverings.

Apply Warning Labels

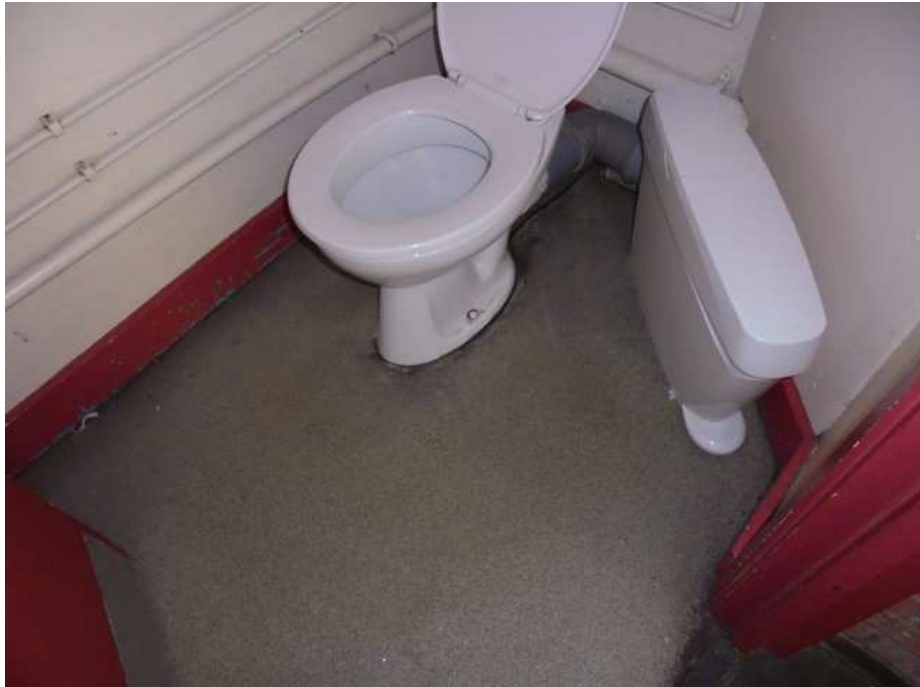
Due to the nature of the survey, no access was gained to inspect below floor coverings.

Apply Warning Labels

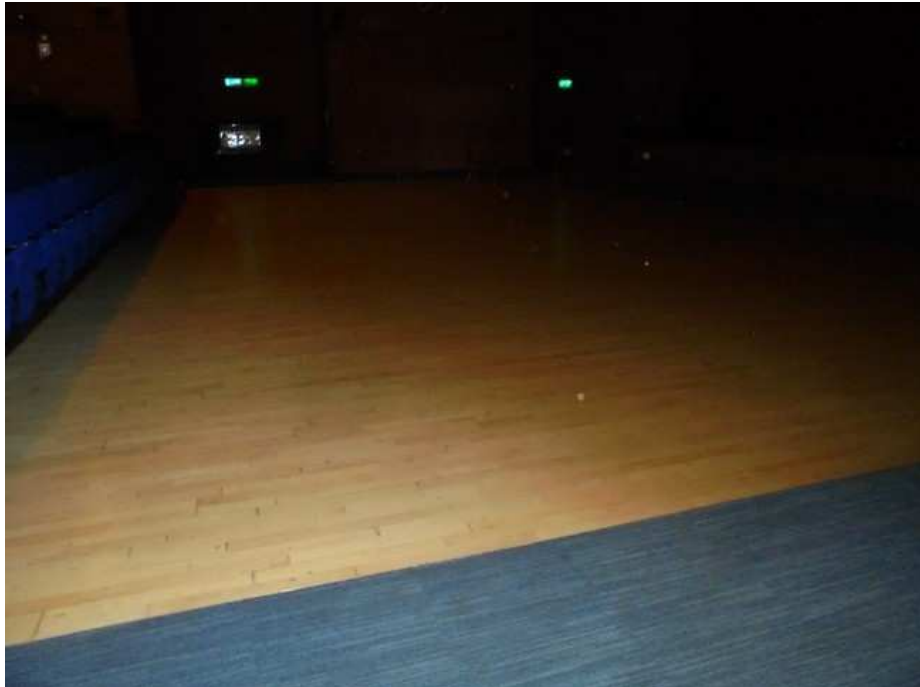
Due to the nature of the survey, no access was gained to inspect below floor coverings.

Apply Warning Labels

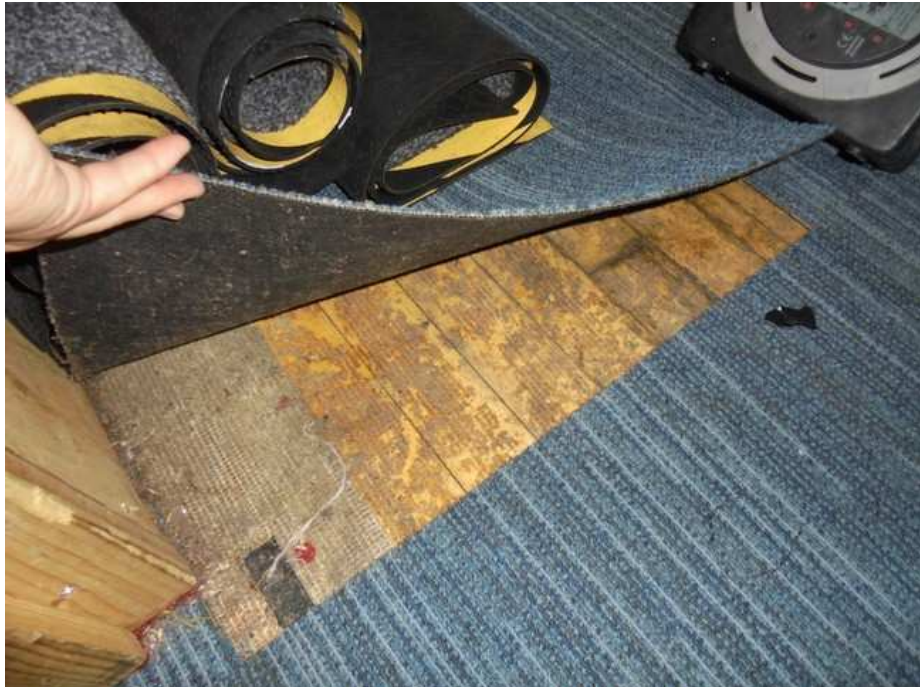
Due to the nature of the survey, no access was gained to inspect below floor coverings.

Apply Warning Labels

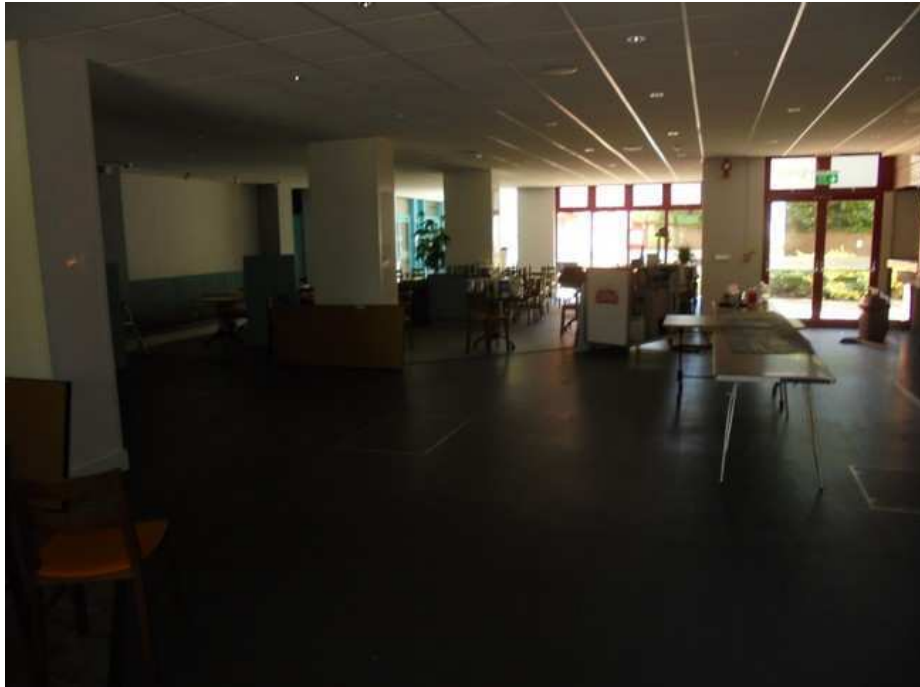
Due to the nature of the survey, no access was gained to inspect below floor coverings.

Apply Warning Labels

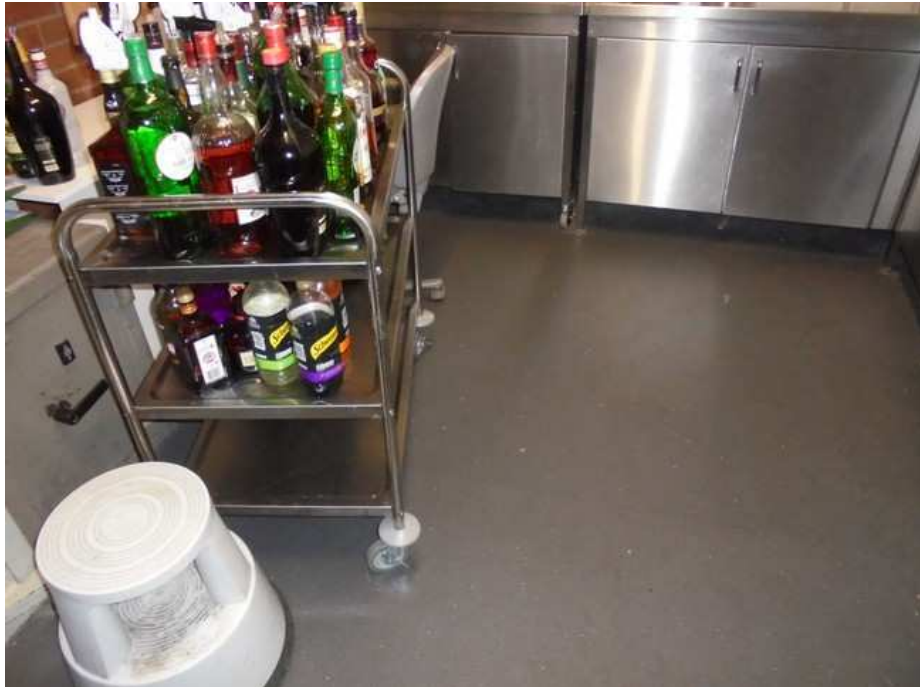
Due to the nature of the survey, no access was gained to inspect below floor coverings.

Apply Warning Labels

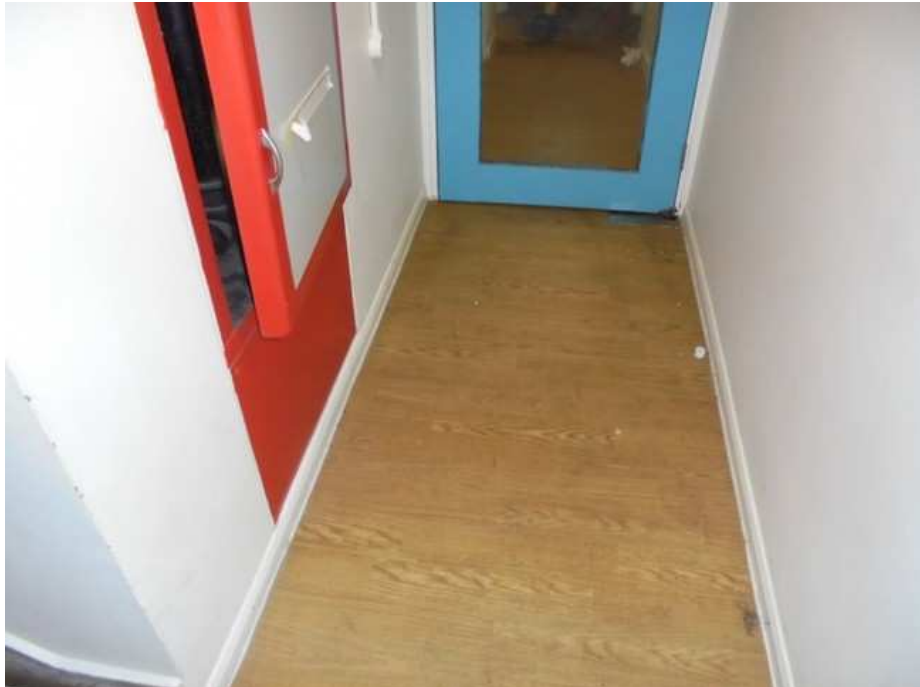
Due to the nature of the survey, no access was gained to inspect below floor coverings.

Apply Warning Labels

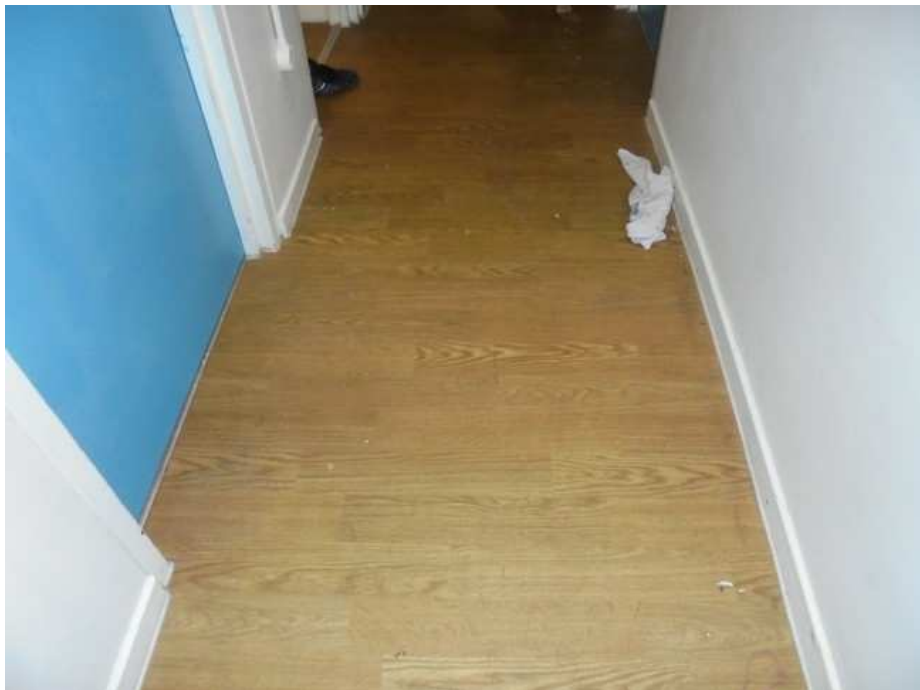
Due to the nature of the survey, no access was gained to inspect below floor coverings.

Apply Warning Labels

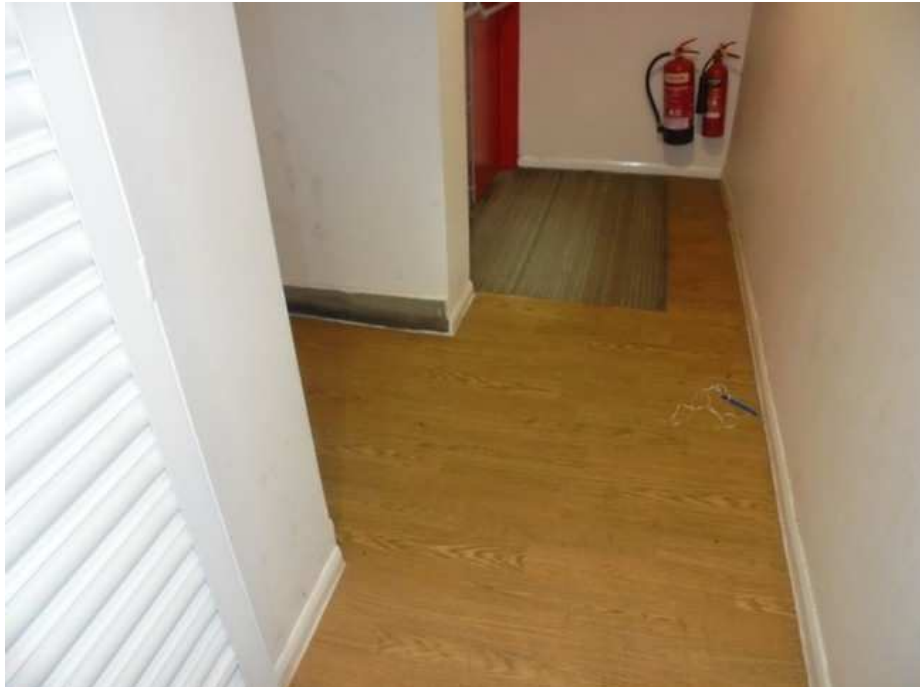
Due to the nature of the survey, no access was gained to inspect below floor coverings.

Apply Warning Labels

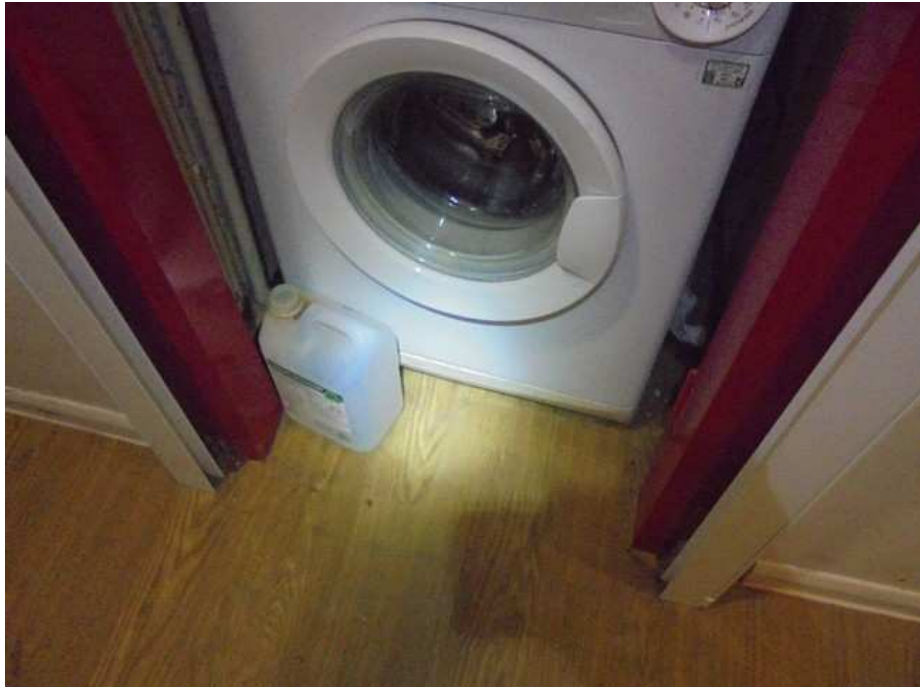
Due to the nature of the survey, no access was gained to inspect below floor coverings.

Apply Warning Labels

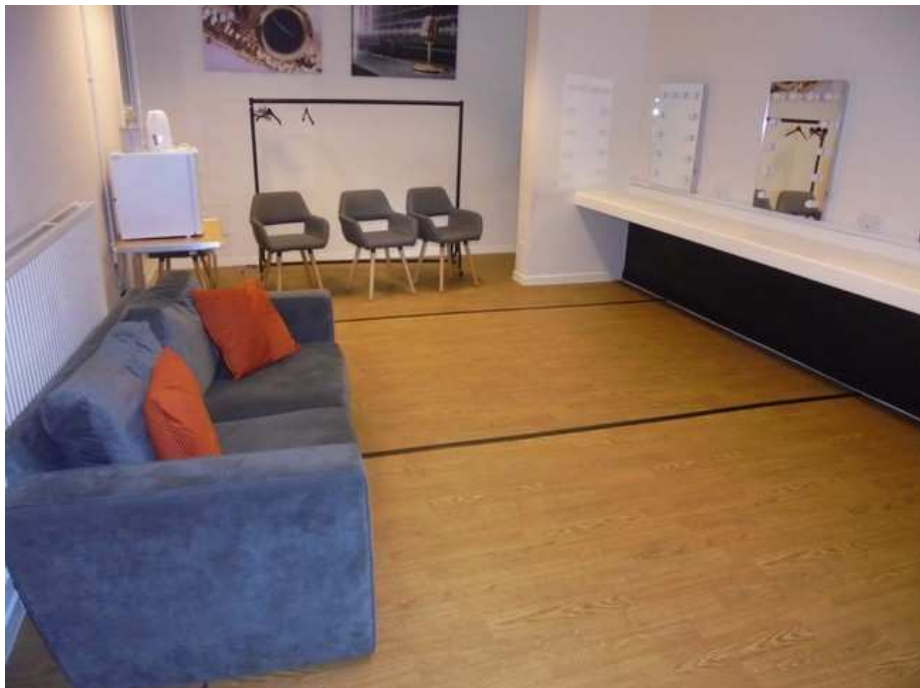
Due to the nature of the survey, no access was gained to inspect below floor coverings.

Apply Warning Labels

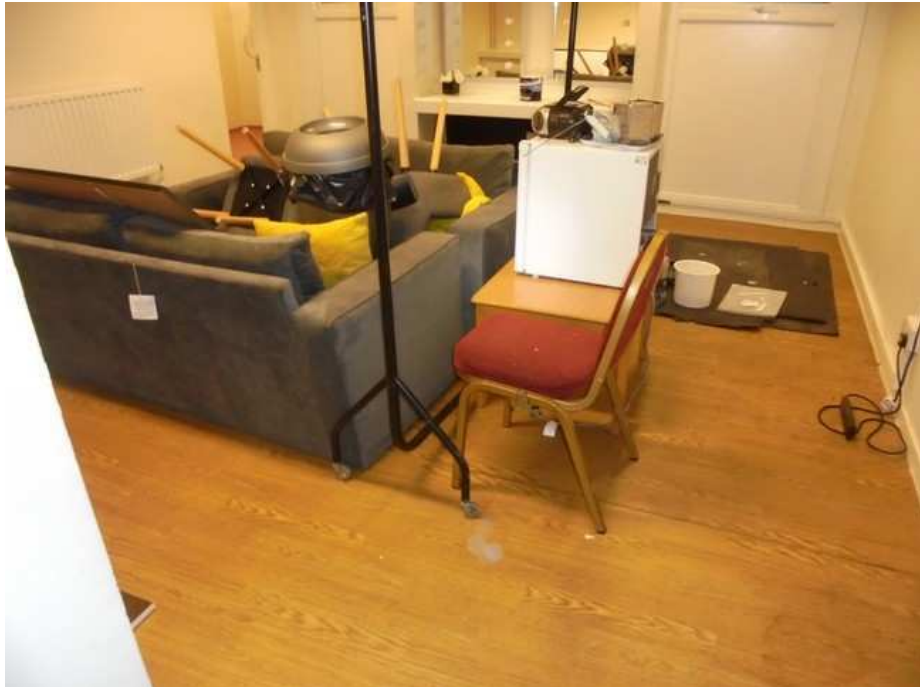
Due to the nature of the survey, no access was gained to inspect below floor coverings.

Apply Warning Labels

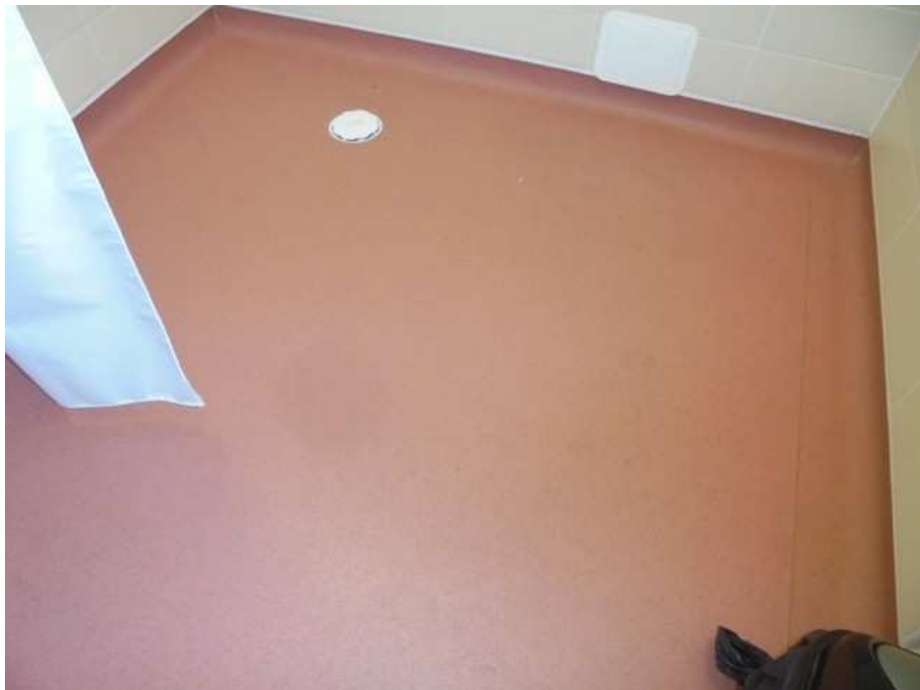
| Product: | Floor tile | Damage: | Good condition |

Material  
Comments:

Due to the nature of the survey, no access was gained to inspect below floor coverings.

Action:

Apply Warning Labels

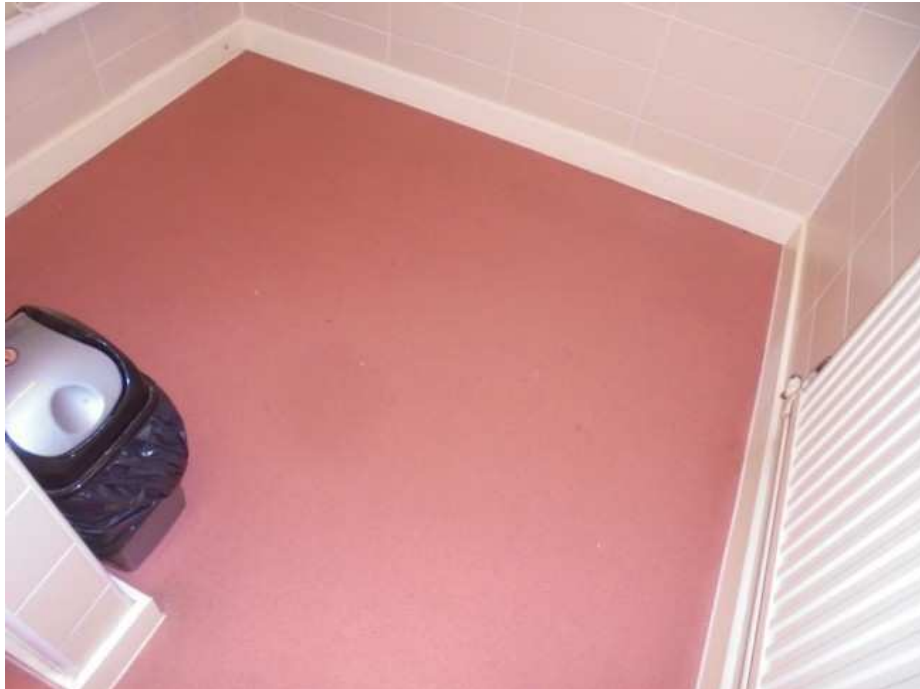
| Product: | Floor tile | Damage: | Good condition |

Material  
Comments:

Due to the nature of the survey, no access was gained to inspect below floor coverings.

Action:

Apply Warning Labels

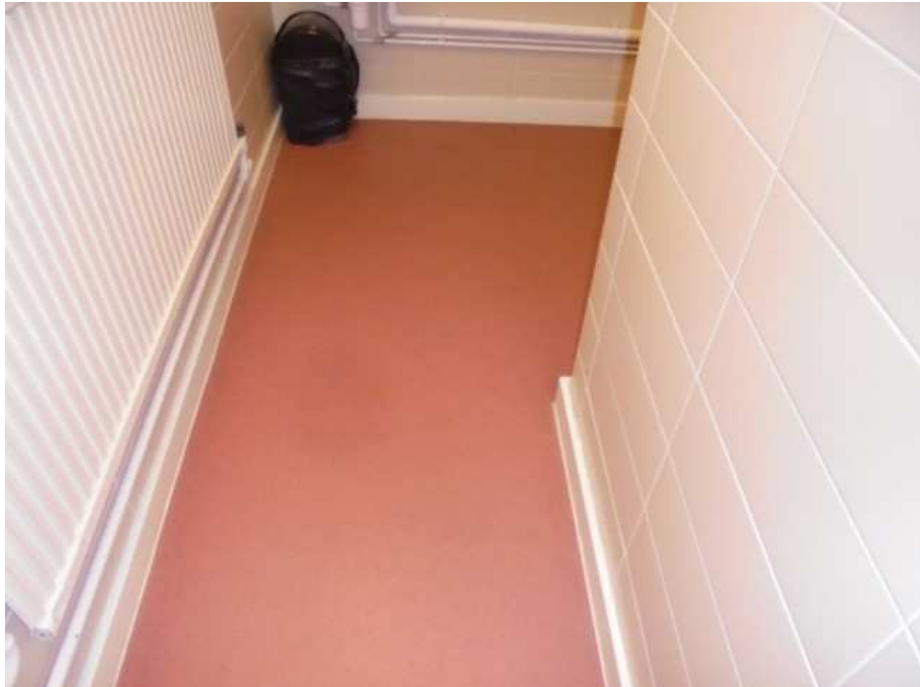
| Product: | Floor tile | Damage: | Good condition |

Material  
Comments:

Due to the nature of the survey, no access was gained to inspect below floor coverings.

Action:

Apply Warning Labels

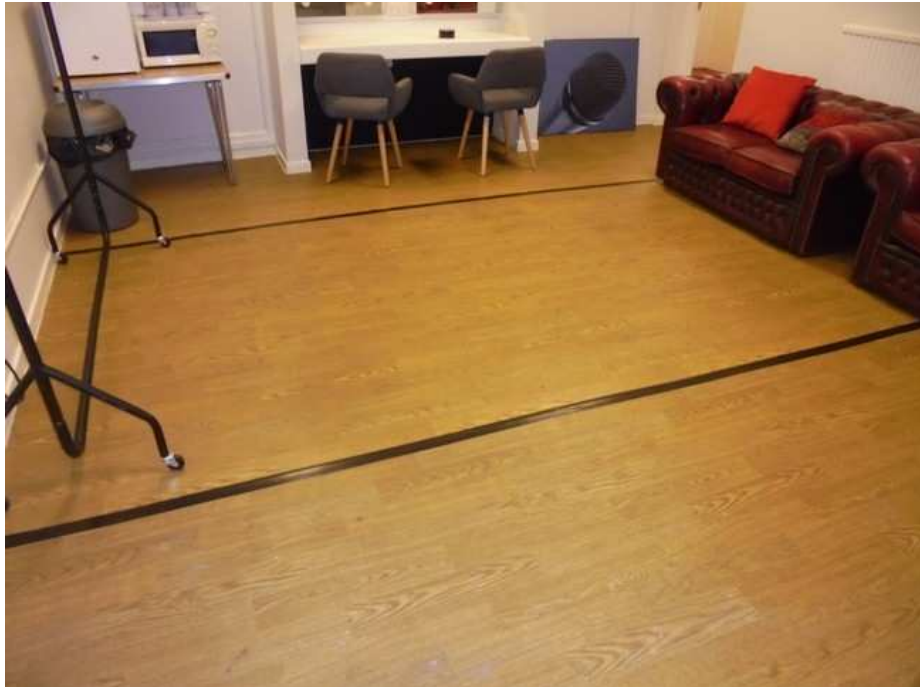
| Product: | Floor tile | Damage: | Good condition |

Material  
Comments:

Due to the nature of the survey, no access was gained to inspect below floor coverings.

Action:

Apply Warning Labels

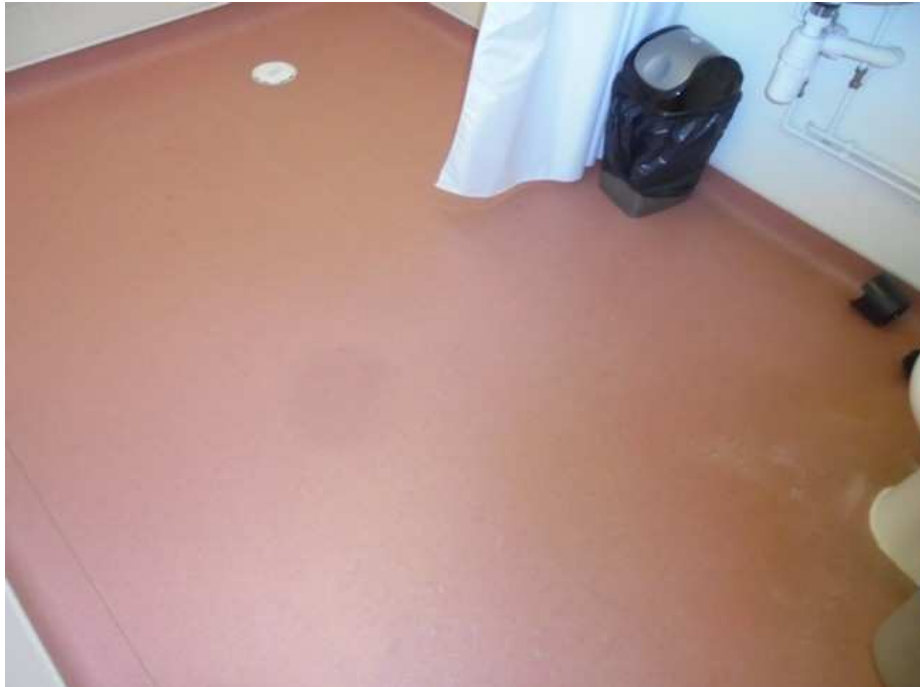
| Product: | Floor tile | Damage: | Good condition |

Material  
Comments:

Due to the nature of the survey, no access was gained to inspect below floor coverings.

Action:

Apply Warning Labels

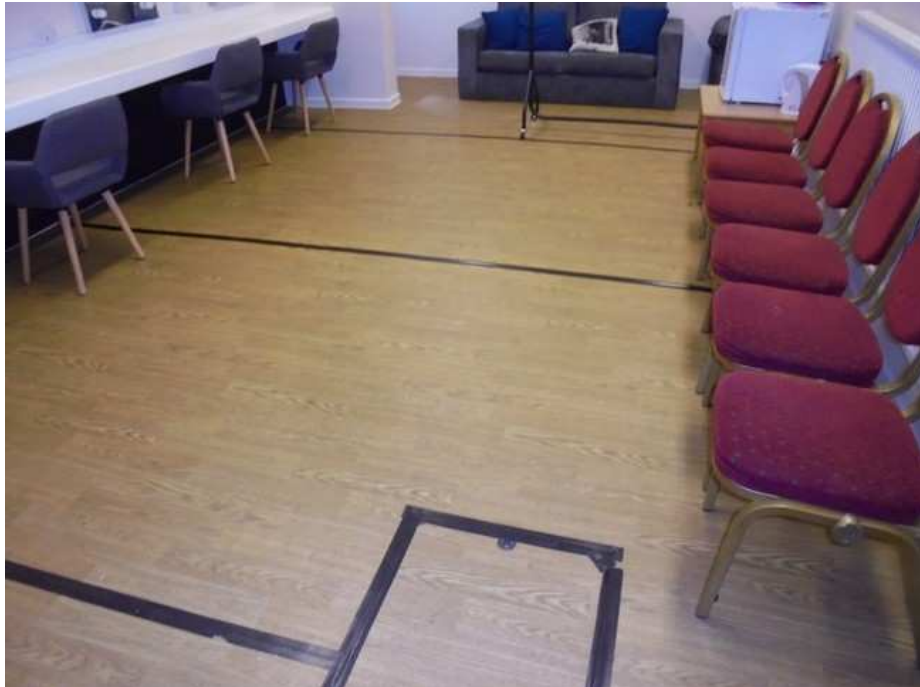
| Product: | Floor tile | Damage: | Good condition |

Material  
Comments:

Due to the nature of the survey, no access was gained to inspect below floor coverings.

Action:

Apply Warning Labels

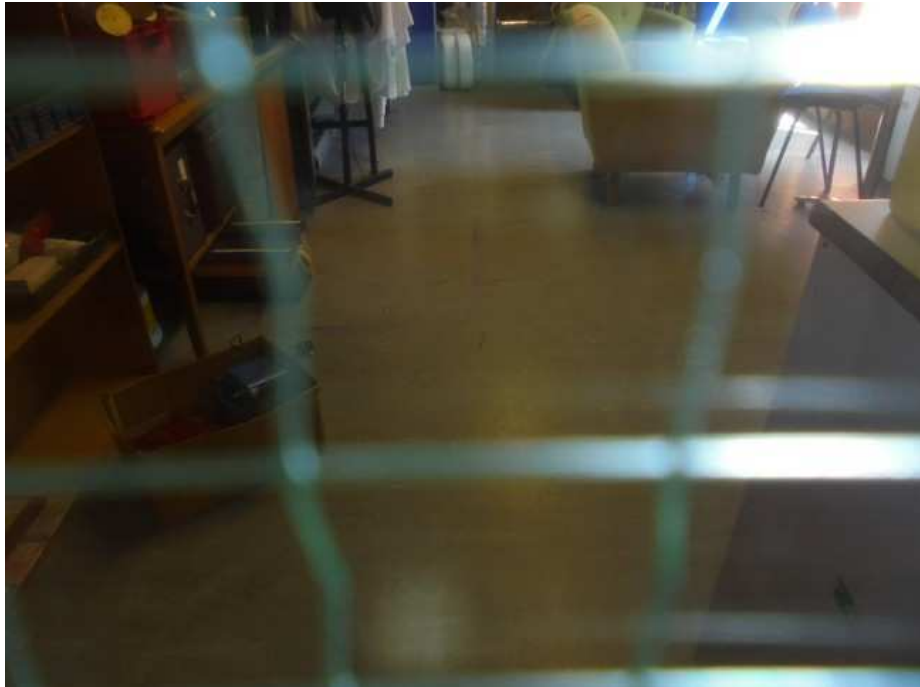
| Product: | Floor tile | Damage: | Good condition |

Material  
Comments:

Due to the nature of the survey, no access was gained to inspect below floor coverings.

Action:

Apply Warning Labels

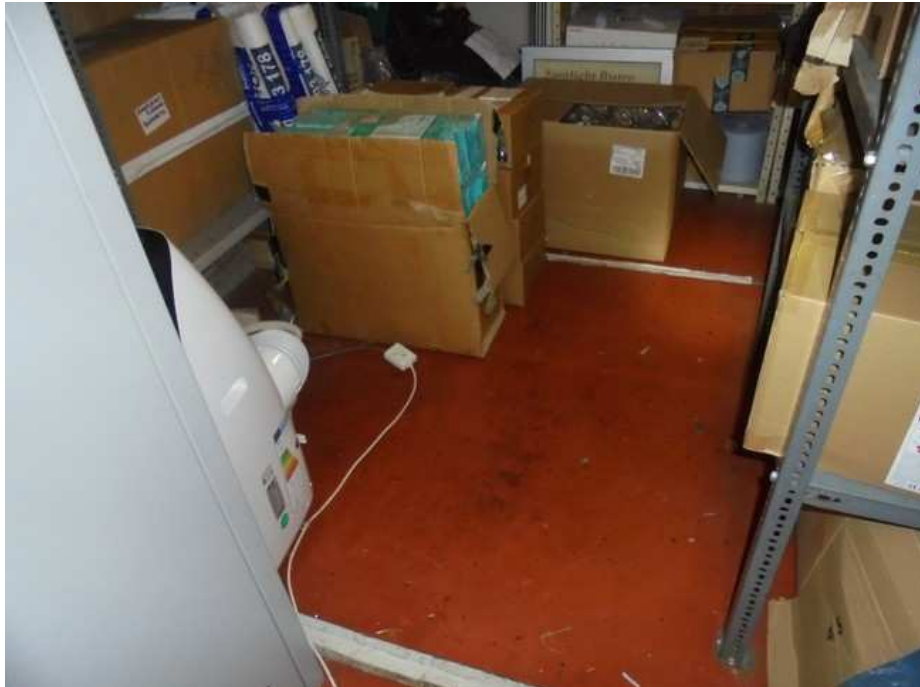
| Product: | Floor tile | Damage: | Good condition |

Material  
Comments:

Due to the nature of the survey, no access was gained to inspect below floor coverings.

Action:

Apply Warning Labels

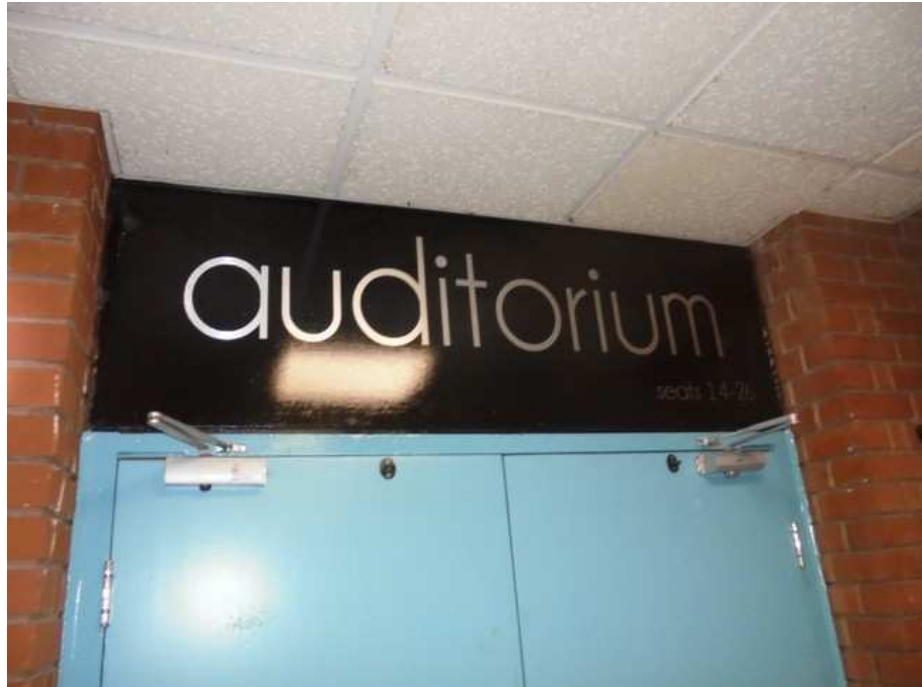
| Product: | Firebreaker Panels | Damage: | Good condition |

Material  
Comments:

Due to the nature of the survey, no access was gained to inspect behind plasterboard & wood firebreaker panels.

Action:

Apply Warning Labels

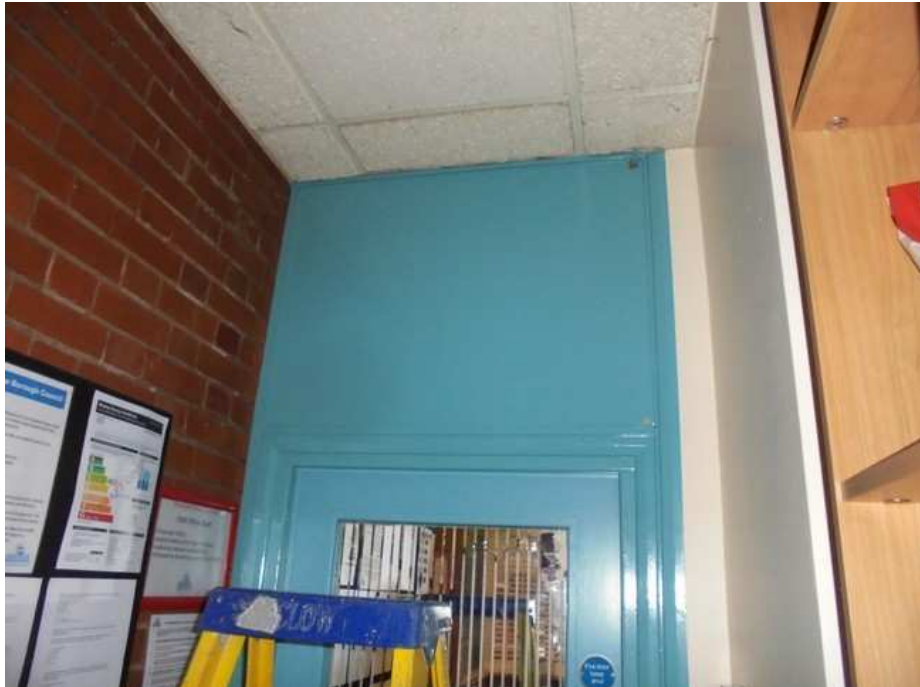
| Product: | Firebreaker Panels | Damage: | Good condition |

Material  
Comments:

Due to the nature of the survey, no access was gained to inspect behind plasterboard firebreaker panels.

Action:

Apply Warning Labels

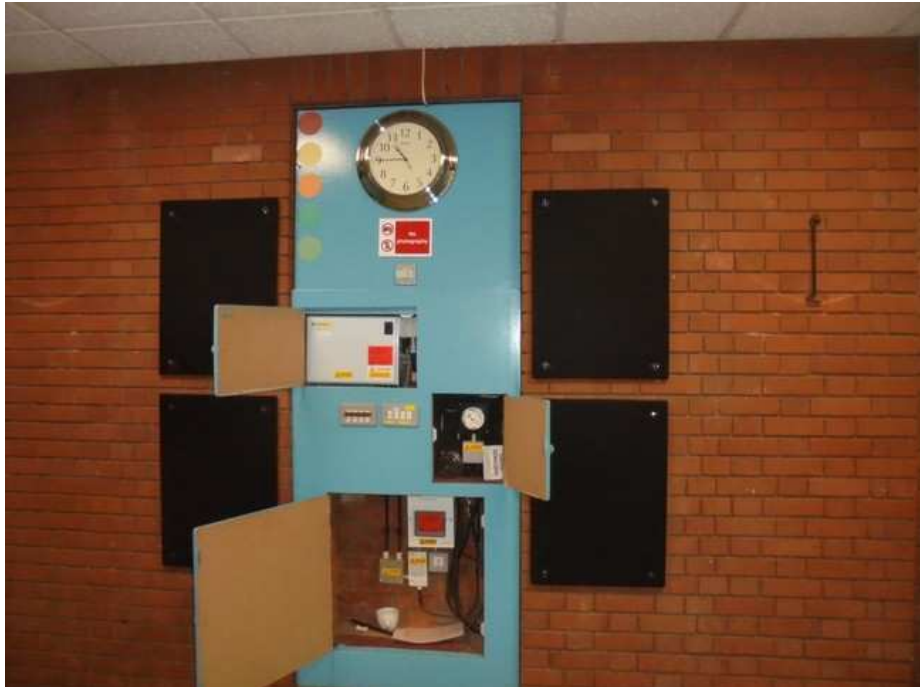
| Product: | Top Panel | Damage: | Good condition |

Material  
Comments:

No access was gained to inspect behind top panel.

Action:

Apply Warning Labels

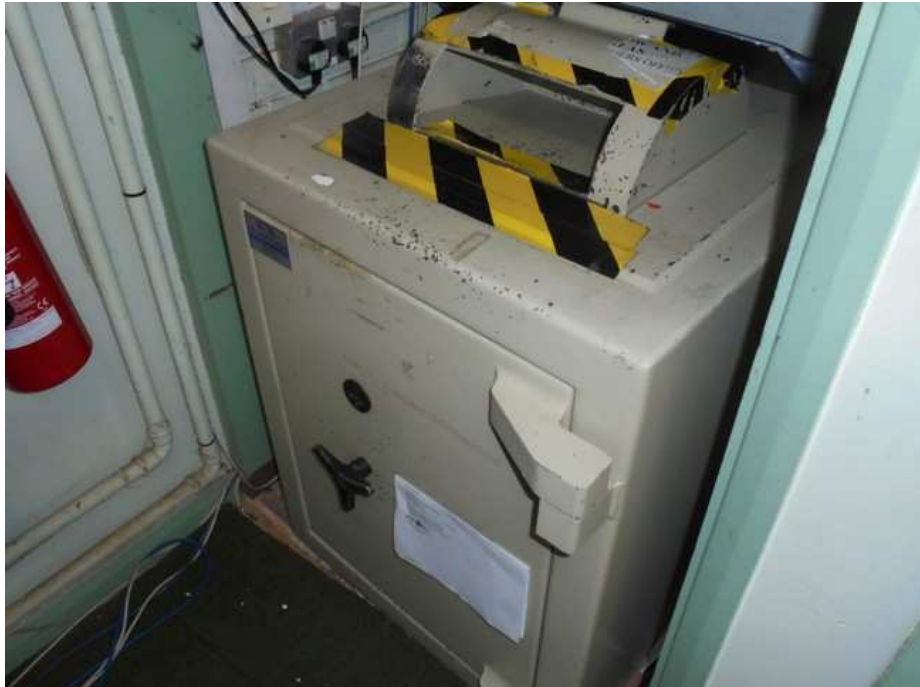
| Product: | Safe Linings | Damage: | Good condition |

Material  
Comments:

No access was gained to inspect within safe units.

Action:

Apply Warning Labels

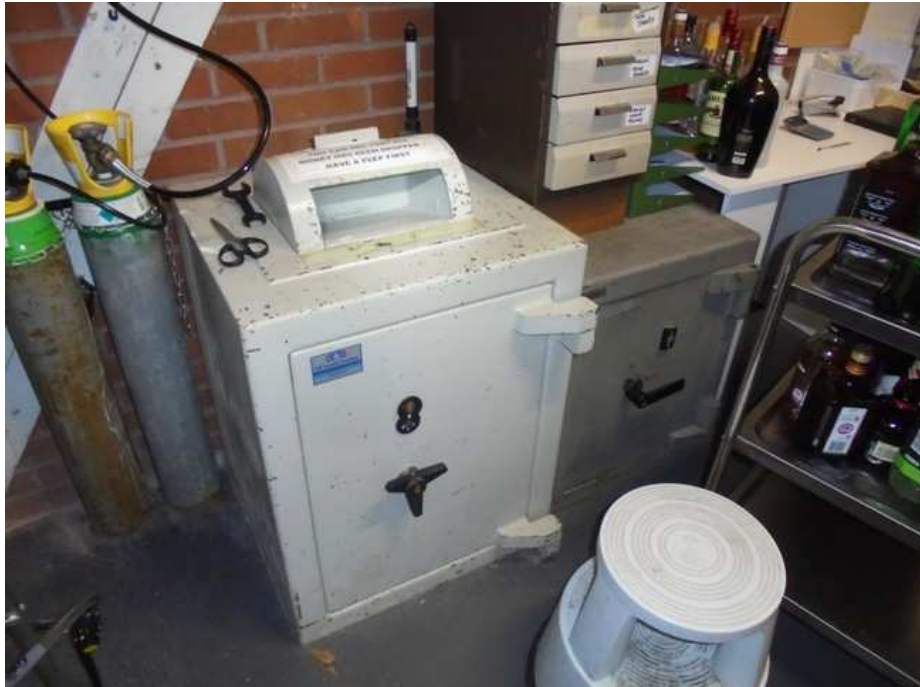
| Product: | Safe Linings | Damage: | Good condition |

Material  
Comments:

No access was gained to inspect within safe units.

Action:

Apply Warning Labels

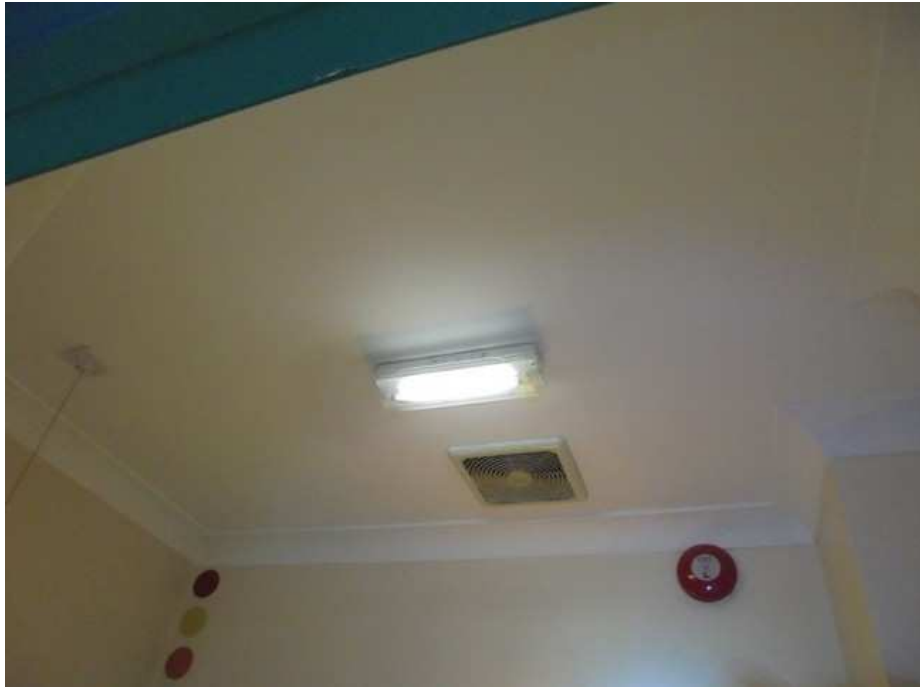
| Product: | Plasterboard Ceiling | Damage: | Good condition |

Material  
Comments:

Due to the nature of the survey, no access was gained to inspect above plasterboard ceiling.

Action:

Apply Warning Labels

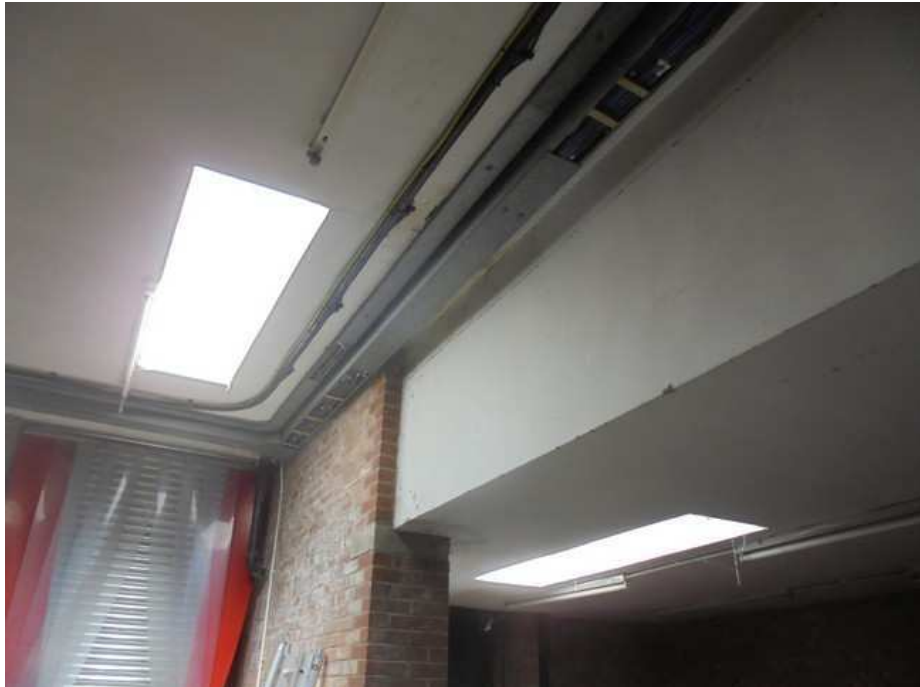
| Product: | Plasterboard Ceiling | Damage: | Good condition |

Material  
Comments:

Due to the nature of the survey, no access was gained to inspect above plasterboard ceiling.

Action:

Apply Warning Labels

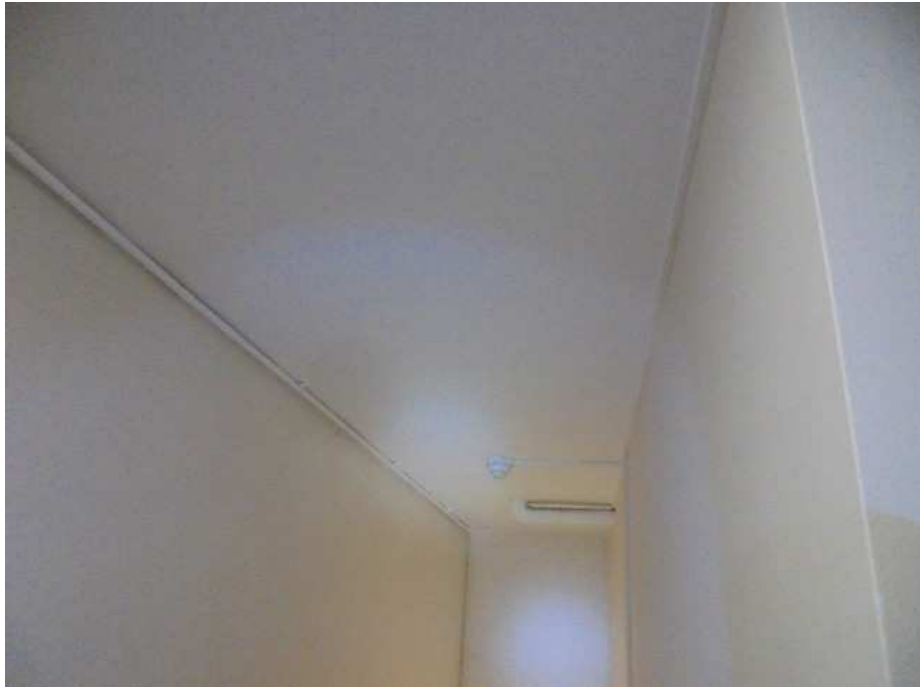
| Product: | Plasterboard Ceiling | Damage: | Good condition |

Material  
Comments:

Due to the nature of the survey, no access was gained to inspect above plasterboard ceiling.

Action:

Apply Warning Labels
