**Asbestos Survey For**

**Advanced Demolition**

**Spotlight**

**In accordance with HSG264**

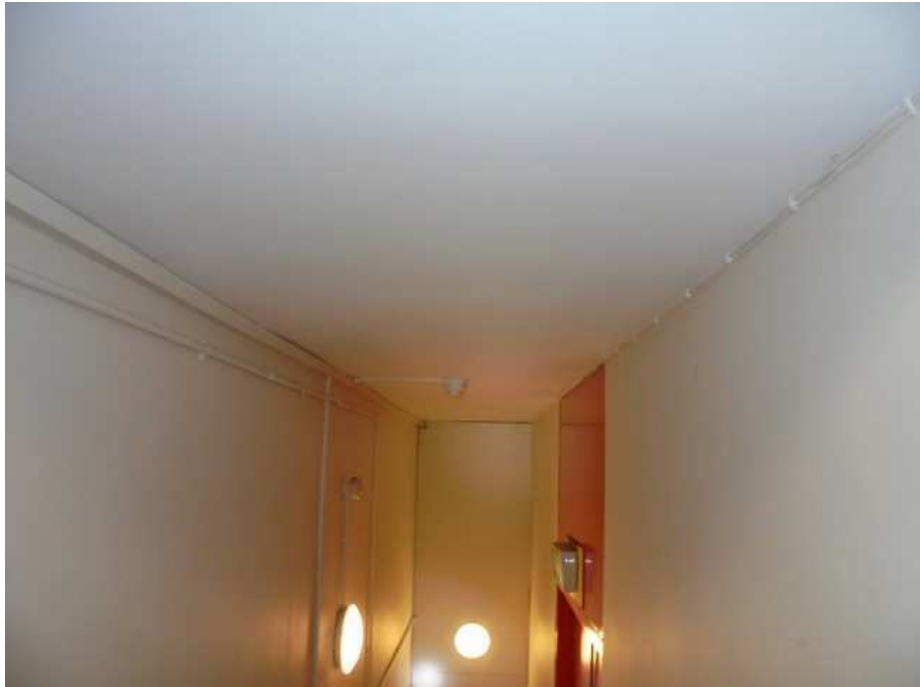
| Product: | Plasterboard Ceiling | Damage: | Good condition |

Material  
Comments:

Due to the nature of the survey, no access was gained to inspect above plasterboard ceiling.

Action:

Apply Warning Labels

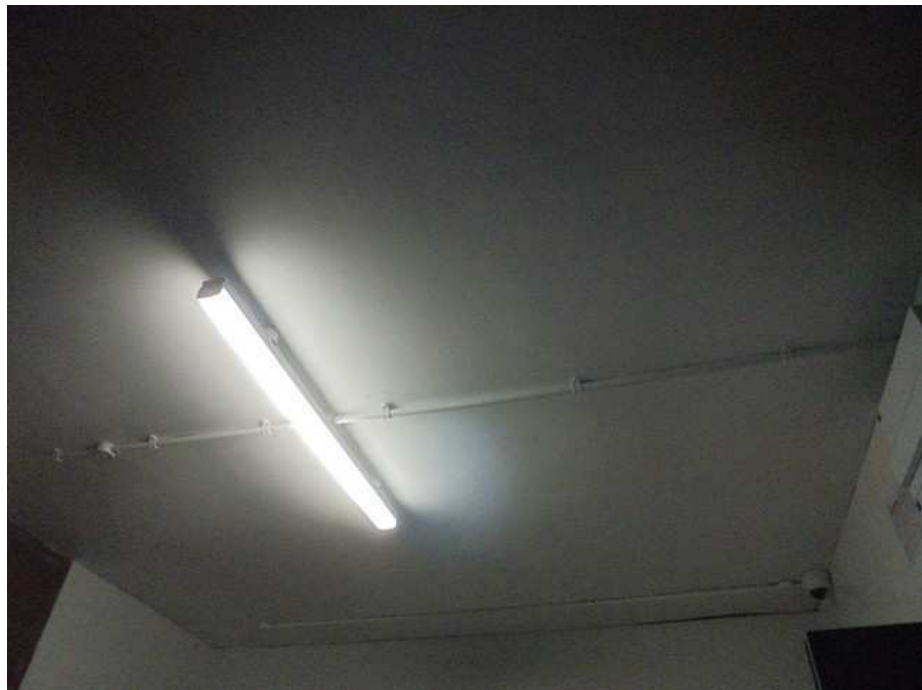
| Product: | Plasterboard Ceiling | Damage: | Good condition |

Material  
Comments:

Due to the nature of the survey, no access was gained to inspect above plasterboard ceiling.

Action:

Apply Warning Labels

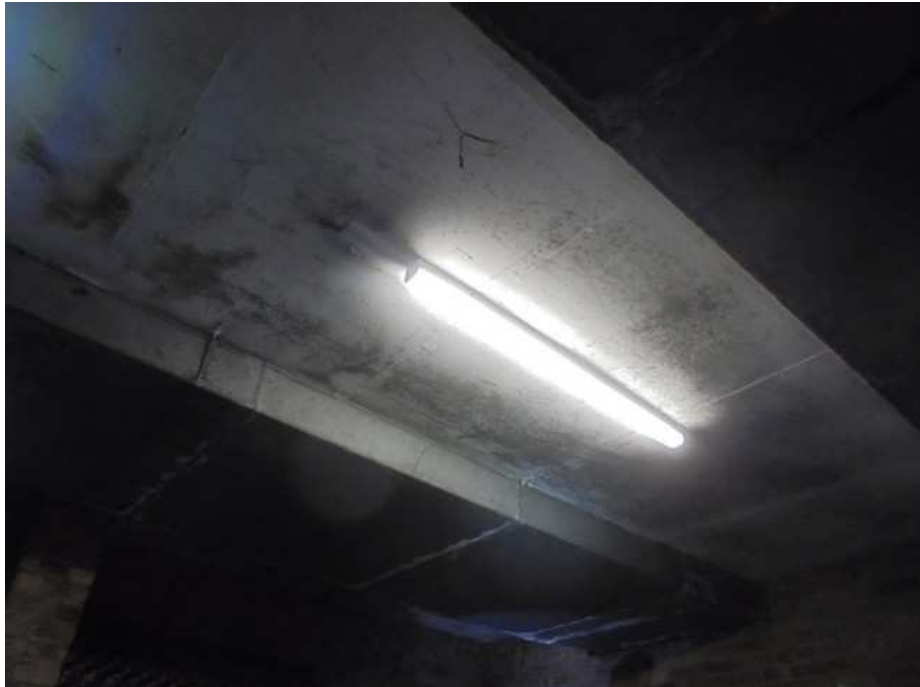
| Product: | Plasterboard Ceiling | Damage: | Good condition |

Material  
Comments:

Due to the nature of the survey, no access was gained to inspect above plasterboard ceiling.

Action:

Apply Warning Labels

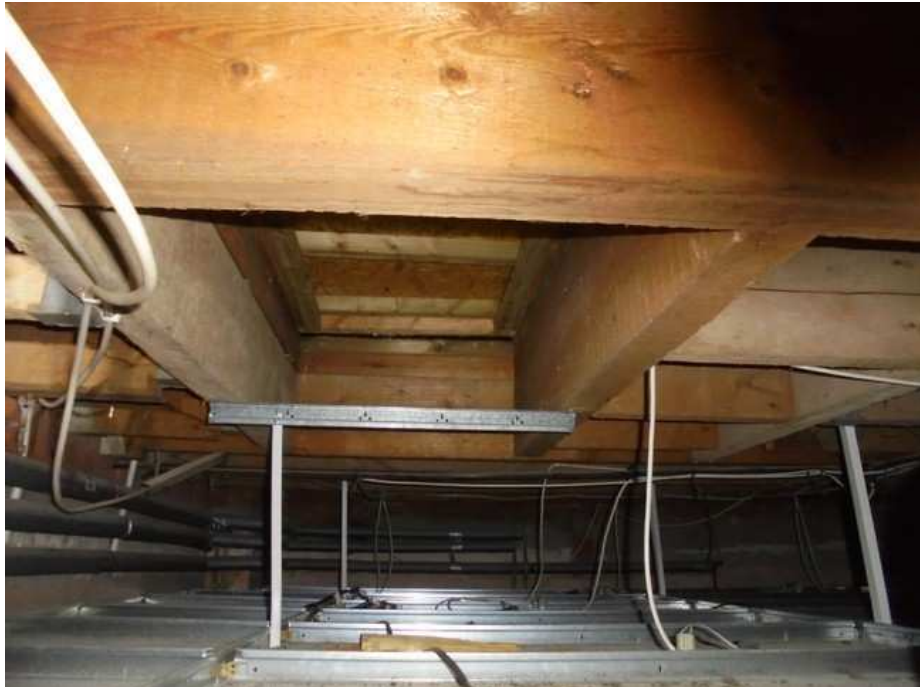
| Product: | Debris to Ceiling Void | Damage: | High damage: Visible debris |

Material Comments:

No access was gained to inspect within ceiling void - debris is presumed to be present.

Action:

Removal By Licenced Contractor

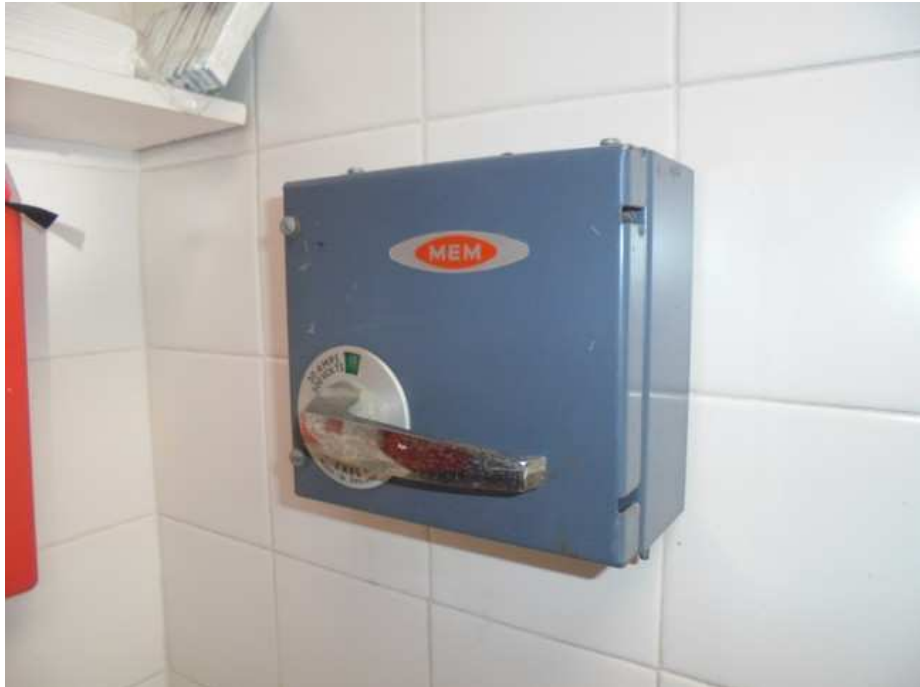
| Product: | Electrics | Damage: | Good condition |

Material  
Comments:

No access was gained to within the electrics due to being live. Presume ACMs present until proven otherwise.

Action:

Apply Warning Labels

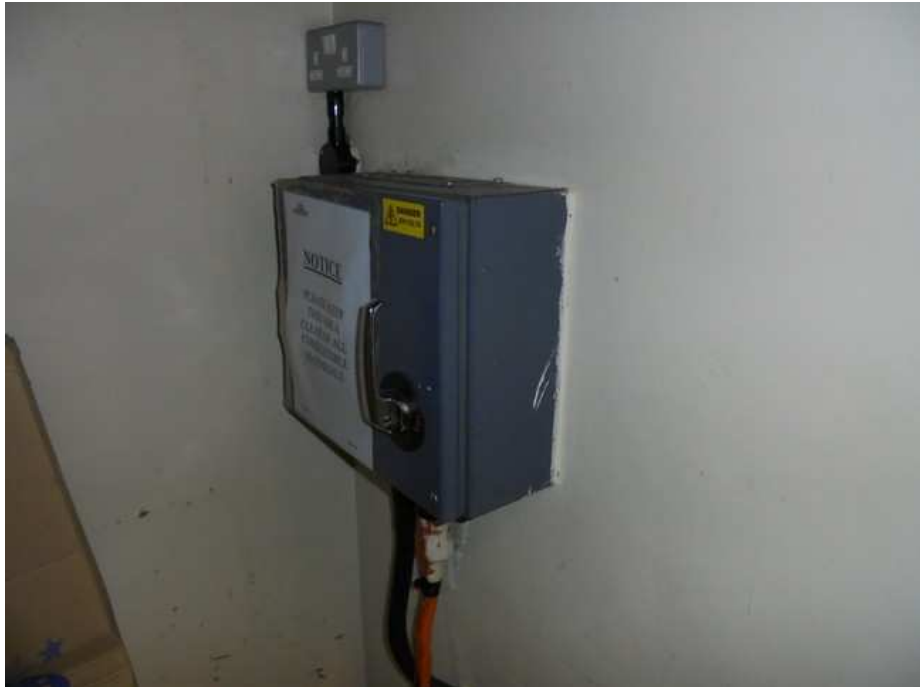
| Product: | Electrics | Damage: | Good condition |

Material  
Comments:

No access was gained to within the electrics due to being live. Presume ACMs present until proven otherwise.

Action:

Apply Warning Labels

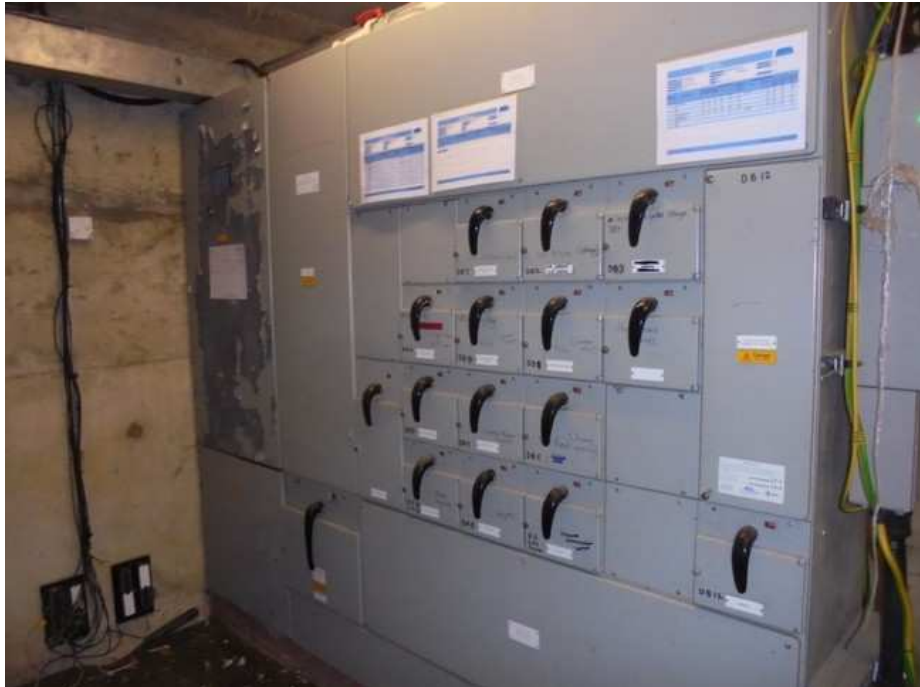
| Product: | Electrics | Damage: | Good condition |

Material  
Comments:

No access was gained to within the electrics due to being live. Presume ACMs present until proven otherwise.

Action:

Apply Warning Labels

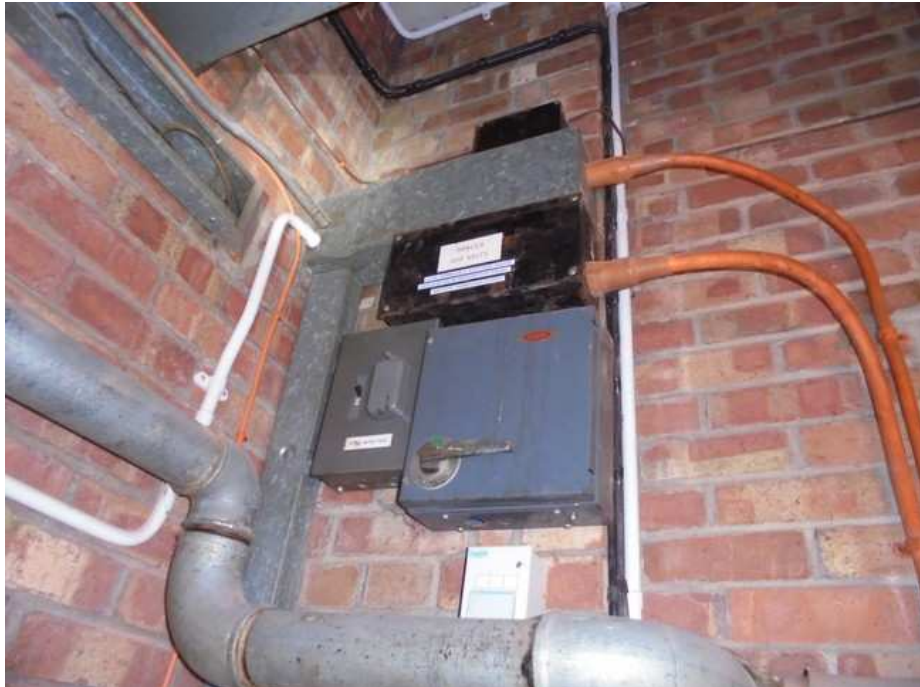
| Product: | Electrics | Damage: | Good condition |

Material  
Comments:

No access was gained to within the electrics due to being live. Presume ACMs present until proven otherwise.

Action:

Apply Warning Labels

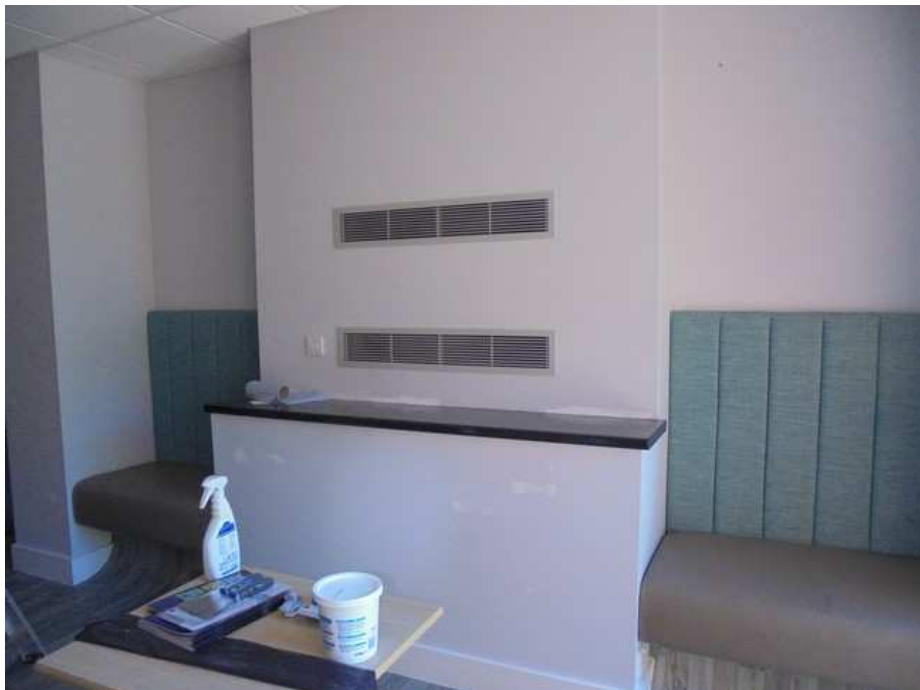
| Product: | Heater Voids | Damage: | Good condition |

Material  
Comments:

No access was gained to inspect within the heater voids.

Action:

Apply Warning Labels

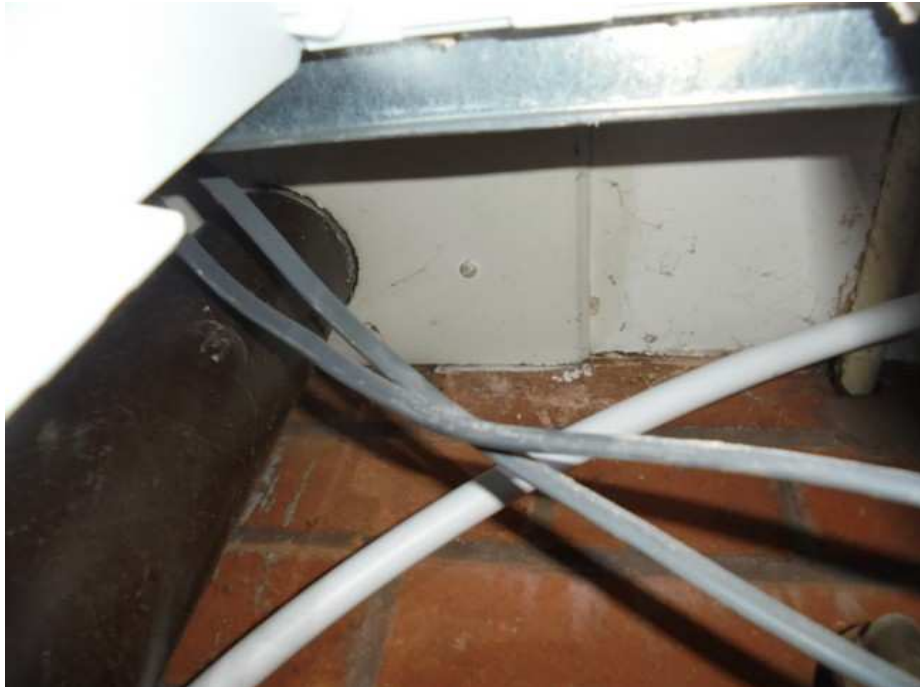
| Product: | Infill panel | Damage: | Good condition |

Material  
Comments:

Due to the nature of the survey, no access was gained to inspect behind UPVC wall void - infill panel is presumed to be present.

Action:

Apply Warning Labels

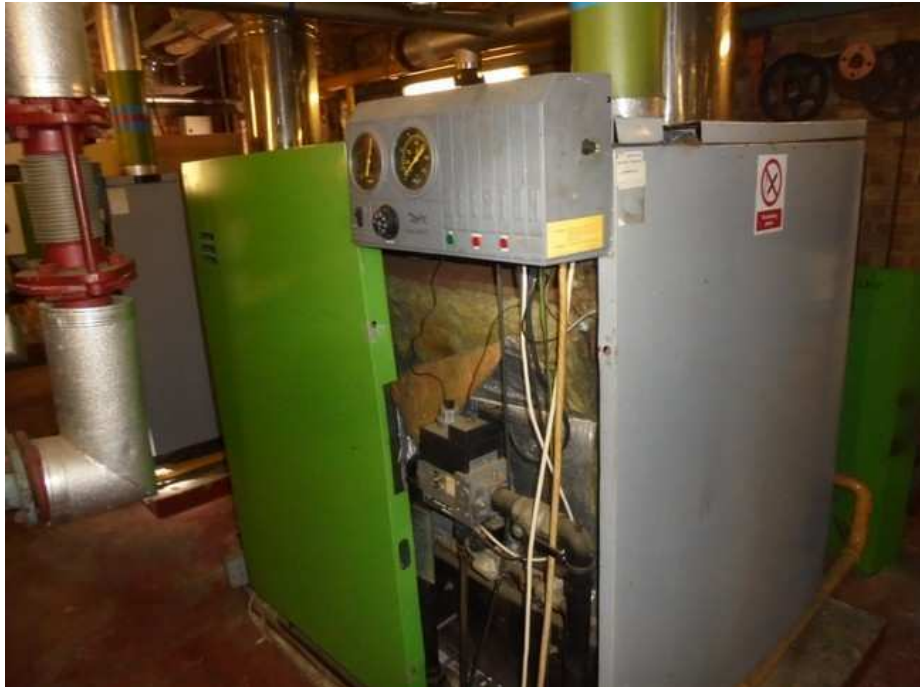
| Product: | Boiler | Damage: | Good condition |

Material  
Comments:

No access was gained to within the boilers due to being live. Presume ACMs present until proven otherwise.

Action:

Apply Warning Labels

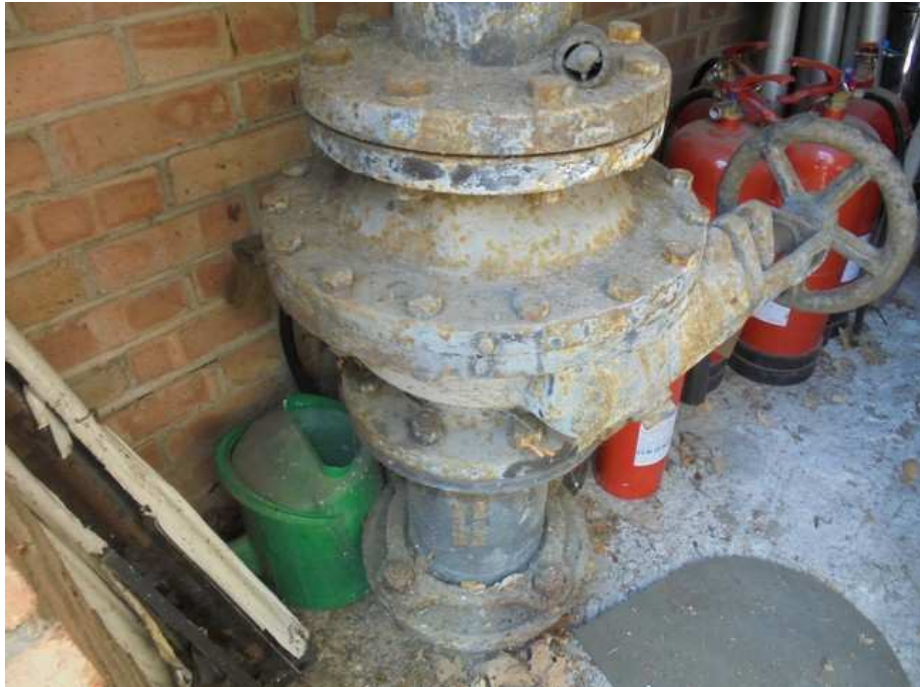
| Product: | Pipe Gasket | Damage: | Good condition |

Material  
Comments:

No access was gained to sample pipe gaskets.

Action:

Apply Warning Labels

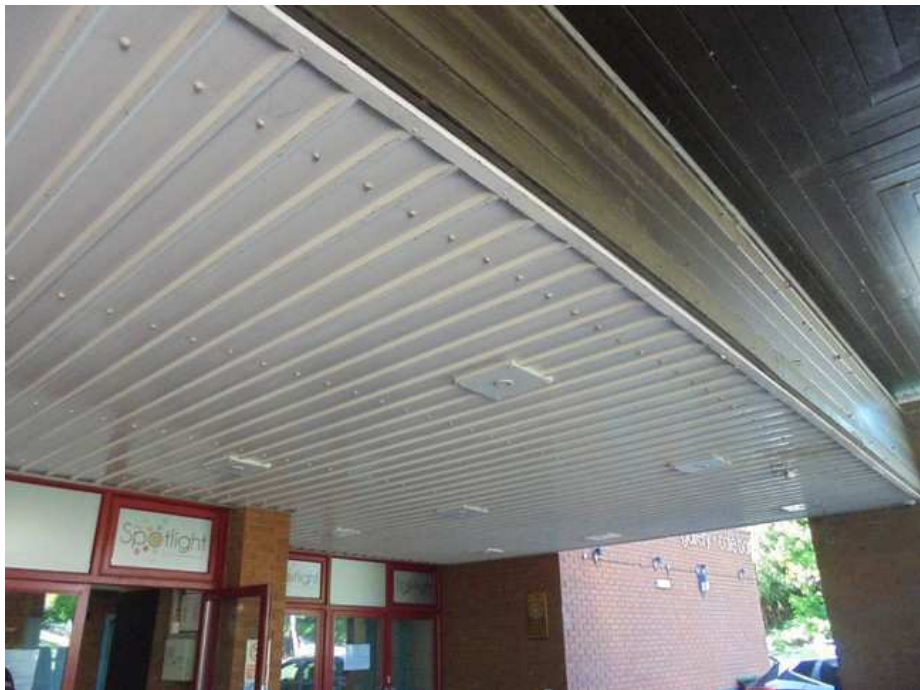
| Product: | Wood Entrance Canopys | Damage: | Good condition |

Material  
Comments:

No access was gained to inspect above wood entrance canopys.

Action:

Apply Warning Labels
